VOLVO V40: 1LLH332			
Vinnumber:	<b>YV1MV74L1G2305695</b>	Versionname:	<b>2.0 D2 KINETIC</b>
First Registrationdate:	<b>20/10/2015</b>	Fiscalpower:	
Expertise Mileage:	<b>74188</b>	Power Kw:	<b>88</b>
Bodytype:		Body color:	<b>Dark Blue</b>
Gearbox:	<b>MAN 6 VIT</b>	Paint type:	<b>Metalic</b>
Transmission:		Rims summer:	<b>Aluminium</b>
Fueltype:	<b>Diesel</b>	Oil level:	<b>OK</b>
Battery functioning:	<b>Yes</b>	Parking lot:	<b>2721</b>
Number of doors:	<b>5</b>		
Number of seats:	<b>5</b>		
Number head rests:	<b>5</b>		
Rims summer:	<b>Aluminium</b>		
Category:	<b>Passenger Car</b>		
Oil level:	<b>OK</b>		
Registration Certificate Car (BE):	<b>Yes</b>

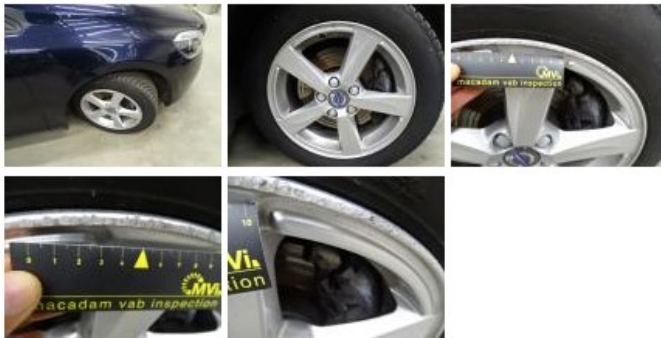
Alloy rim F R, Scratch(es), LI - Repair and paint (complete) 95,00
