VOLVO V40: 1EPB903			
Vinnumber:	<b>YV1MV8481D2040494</b>	Versionname:	<b>V40 D2 Base 115PK</b>
First Registrationdate:	<b>12/02/2013</b>	Fiscalpower:	
Expertise Mileage:	<b>83772</b>	Power Kw:	<b>84</b>
Bodytype:		Body color:	<b>Dark Blue</b>
Gearbox:	<b>MAN 6 VIT</b>	Paint type:	<b>Metalic</b>
Transmission:		Rims summer:	<b>Aluminium</b>
Fueltype:	<b>Diesel</b>	Oil level:	<b>OK</b>
Battery functioning:	<b>Yes</b>	Parking lot:	<b>2820</b>
Number of doors:	<b>5</b>		
Number of seats:	<b>5</b>		
Number head rests:	<b>5</b>		
Rims summer:	<b>Aluminium</b>		
Category:	<b>Passenger Car</b>		
Oil level:	<b>OK</b>

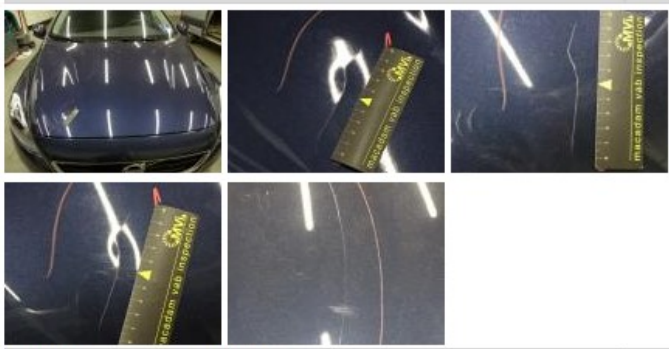
Assistance equipment			
Repair kit	<b>Yes</b>	Compressor	<b>Yes</b>
Total cost ex VAT			<b>2397,96</b>
Bonnet, Bump(s) and scratch(es), LI - Repair and paint (complete)			<b>290,08</b>

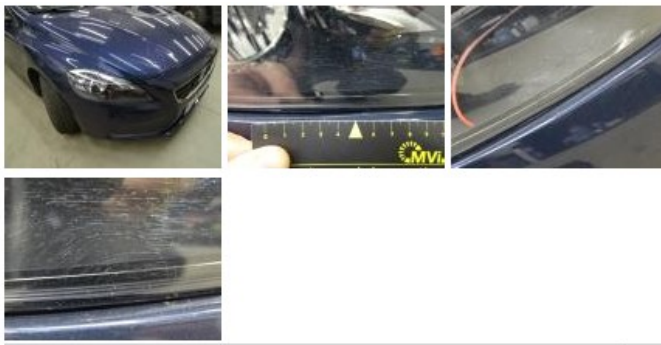
Headlight R, Damaged, E - Replace	<b>396,00</b>
-----------------------------------	---------------

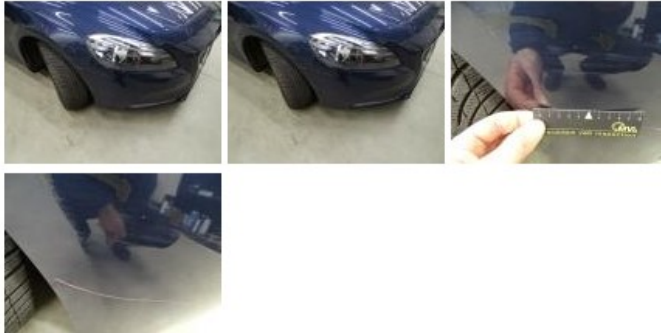
Front bumper, Scratch(es), LI - Repair and paint (complete) 211,80

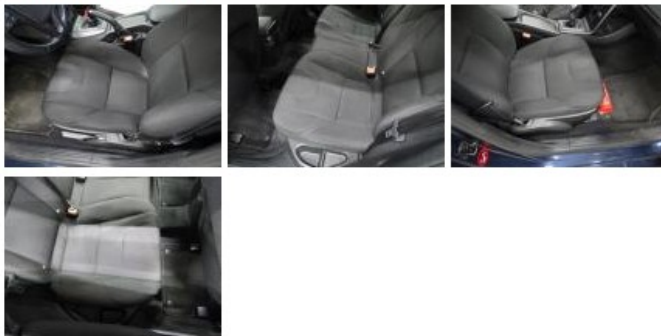
Interior, Dirty, Cleaning 50,00

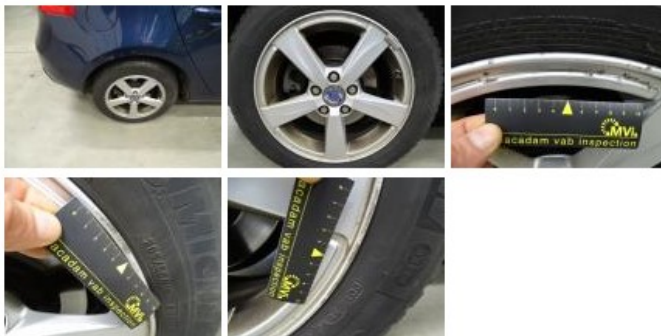
Alloy rim R R, Scratch(es), LI - Repair and paint (complete) 95,00
