## VOLVO S60: 1FTH217

## Limited Technical Inspection

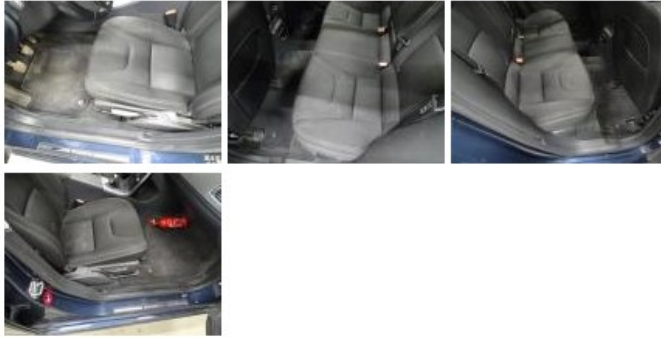
Interior, Dirty, Cleaning	100,00
---------------------------	--------
