BMW 3: 1BIZ668

Vinnumber:	WBAUY11040F046732	Versionname:	3 TOURING 320d 163PK
First Registrationdate:	10/06/2011	Fiscalpower:	
Expertise Mileage:	172493	Power Kw:	120
Bodytype:	Break	Body color:	Silver
Gearbox:	MAN 6 VIT	Paint type:	Metalic
Transmission:	Back	Rims summer:	Aluminium
Fueltype:	Diesel	Oil level:	OK
Maintenance:	OK	Parking lot:	3513
Battery functioning:	Yes		
Number of doors:	5		
Number of seats:	5		
Number head rests:	5		
Rims summer:	Aluminium		
Category:	Passenger Car		
Oil level:	OK		
Registration Certificate Car (BE):	Yes

Limited Technical Inspection

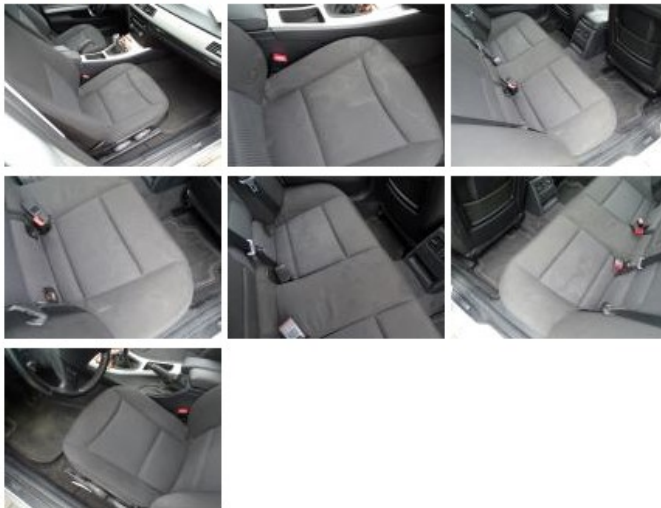
Interior, Stain, Cleaning 100,00

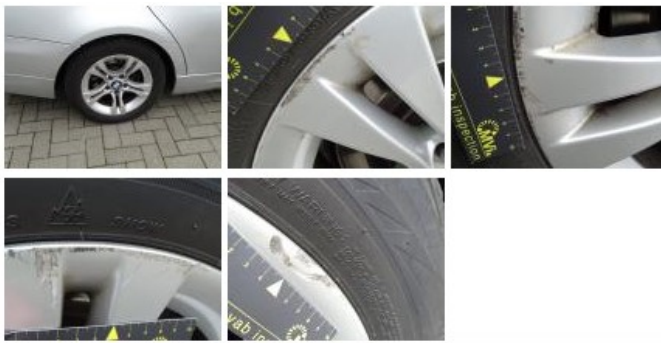
Alloy rim R R, Scratch(es), LI - Repair and paint (complete) 95,00

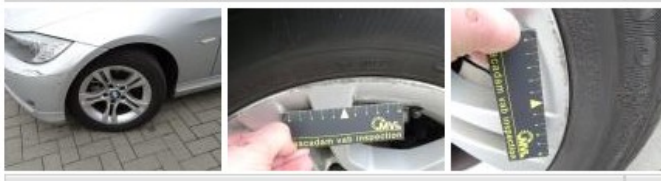
Alloy rim F L, Scratch(es), LI - Repair and paint (complete) 95,00
