| BMW 5: 1GNF878 | | | |
| Vinnnumber: | WBA5J11010D335958 | Versionname: | 5 TOURING 518d 136PK |

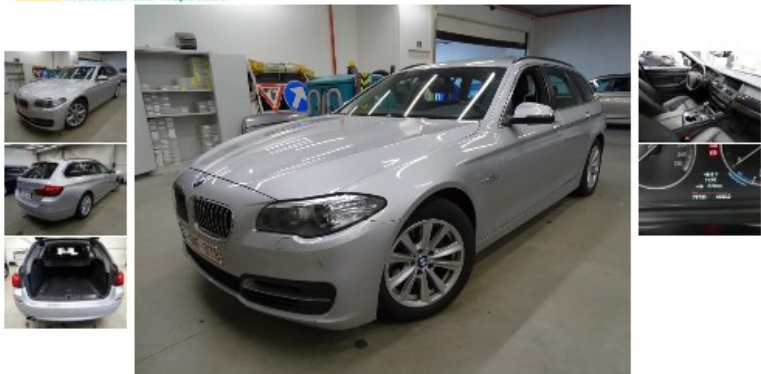
| Wing F L, Bad repair, Paint | | | 0,00 |
