#### FORD S Max: 1EXM127

| Vinnnumber: | <b>WF0SXXGBWSDJ88498</b> | Versionname: | <b>S-MAX Econetic Titanium</b> |

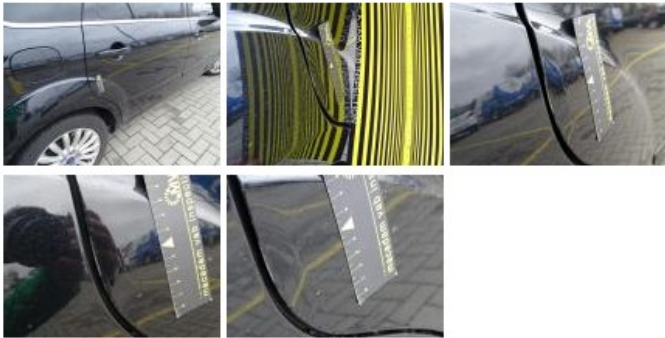
| Door R R, Bump(s), LI - Repair and paint (complete) | 382,02 |

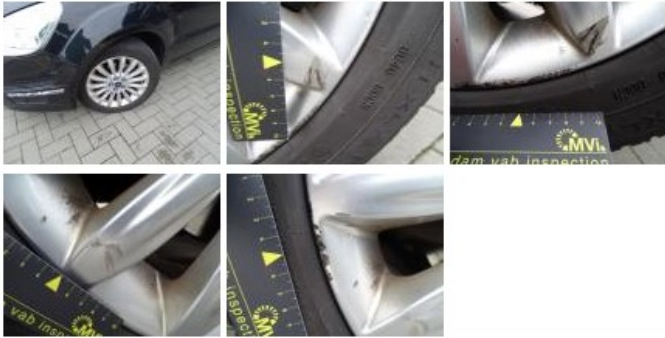
| Alloy rim F L, Scratch(es), LI - Repair and paint (complete) | 95,00 |
