VOLVO V70: 1EDZ057

Limited Technical Inspection

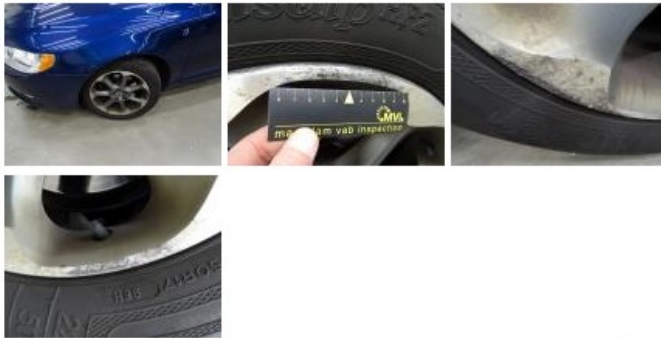
Alloy rim F R polished, Scratch(es), LI - Repair and paint (complete) 95,00
