BMW X1: 1DGY926			
Vinnumber:	WBAVN11000VU53918	Versionname:	X1 sDrive18 136PK
First Registrationdate:	14/05/2012	Fiscalpower:	
Expertise Mileage:	98876	Power Kw:	100
Bodytype:	SUV	Body color:	Brown
Gearbox:	MAN 6 VIT	Paint type:	Metalic
Transmission:		Rims summer:	Aluminium
Fueltype:	Diesel	Oil level:	OK
Battery functioning:	Yes	Parking lot:	1513
Number of doors:	5		
Number of seats:	5		
Number head rests:	5		
Rims summer:	Aluminium		
Category:	Passenger Car		
Oil level:	OK

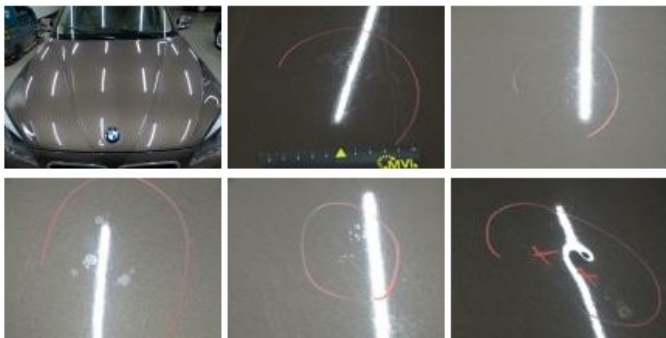
Assistance equipment			
Repair kit	Yes	Compressor	Yes
Total cost ex VAT			1665,06
Bonnet, Chemical polution, LI - Repair and paint (complete)			290,08

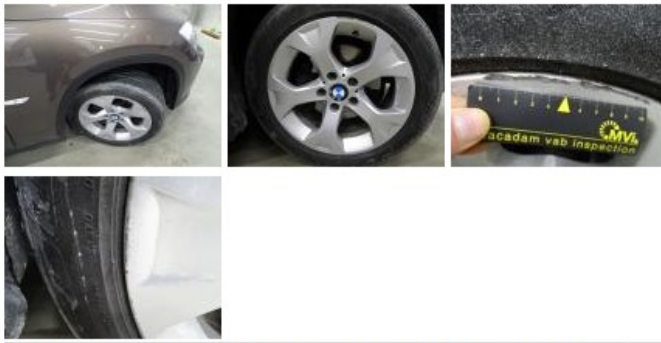
Alloy rim F L, Scratch(es), Acceptable		0,00
<i>No pictures to display</i>		
Front bumper, Bump(s), Acceptable		0,00
<i>No pictures to display</i>		
Alloy rim F R, Scratch(es), LI - Repair and paint (complete)		95,00
