AUDI A6: 1FRV030			
Vinnumber:	<b>WAUZZZ4G7EN053570</b>	Versionname:	<b>A6 AVANT 163PK</b>
First Registrationdate:	<b>4/10/2013</b>	Fiscalpower:	
Expertise Mileage:	<b>75874</b>	Power Kw:	<b>120</b>
Bodytype:	<b>Break</b>	Body color:	<b>Light Grey</b>
Gearbox:	<b>MAN 6 VIT</b>	Paint type:	<b>Metalic</b>
Transmission:		Rims summer:	<b>Aluminium</b>
Fueltype:	<b>Diesel</b>	Oil level:	<b>OK</b>
Battery functioning:	<b>Yes</b>	Parking lot:	<b>1215</b>
Number of doors:	<b>5</b>		
Number of seats:	<b>5</b>		
Number head rests:	<b>5</b>		
Rims summer:	<b>Aluminium</b>		
Category:	<b>Passenger Car</b>		
Oil level:	<b>OK</b>		
Registration Certificate Car (BE):	<b>Yes</b>

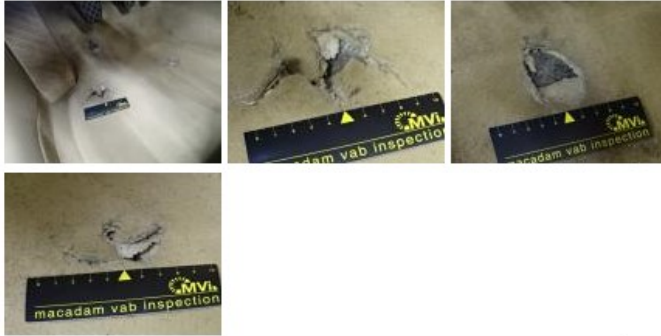
Floor covering F L, Damaged, E - Replace

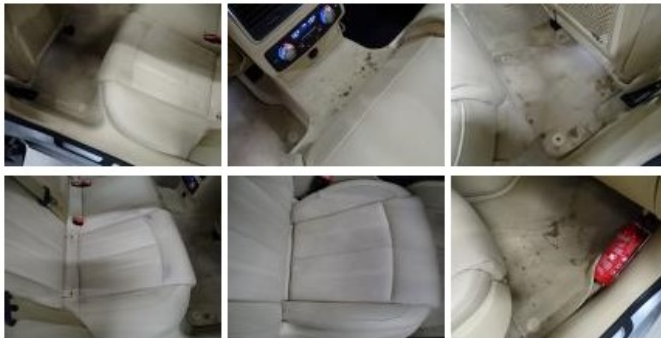
Interior, Dirty, Cleaning

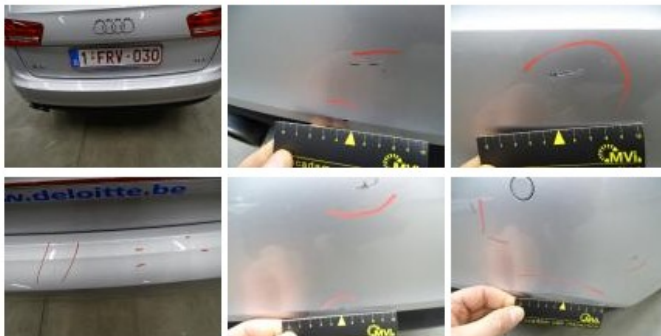
Bumper R, Scratch(es), LI - Repair and paint (complete)

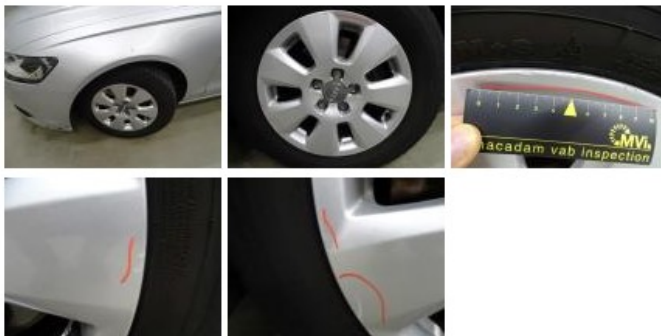
Alloy rim F L, Scratch(es), LI - Repair and paint (complete)

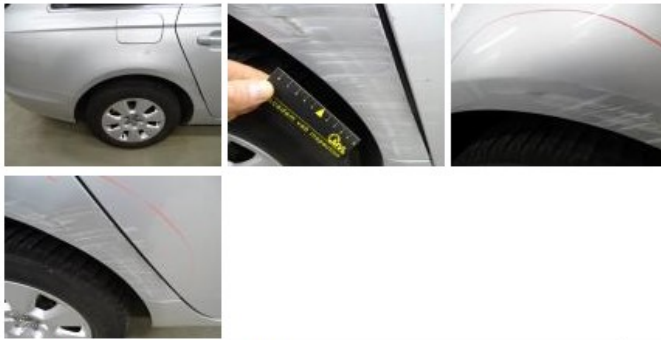
Wing R R, Bump(s) and scratch(es), LI - Repair and paint (complete) 369,84

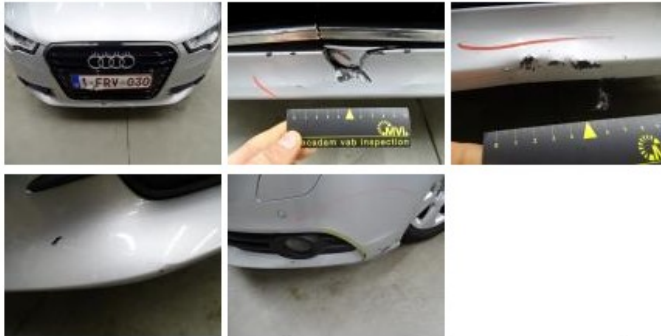
Front bumper, Damaged, Le - Replace and paint 862,80

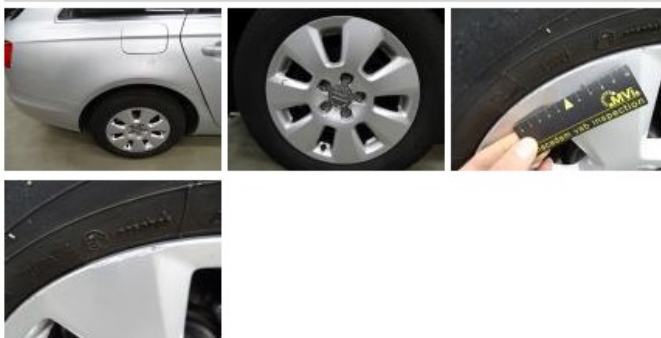
Alloy rim R R, Scratch(es), LI - Repair and paint (complete) 95,00
