**FORD Mondeo: 1EYA735**

**Limited Technical Inspection**

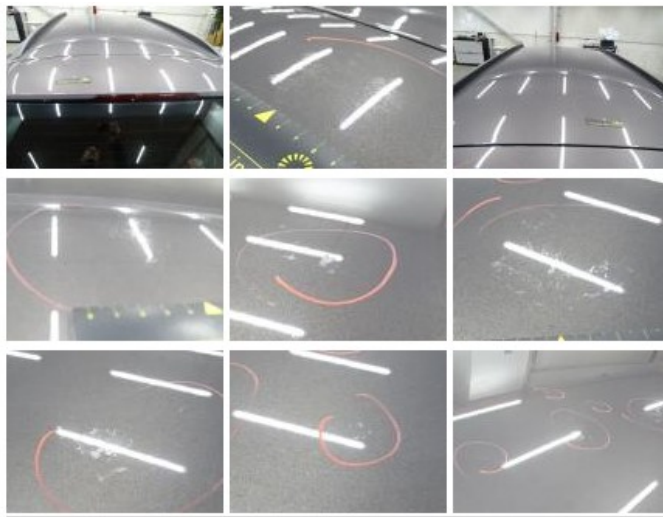
Roof, Chemical polution, LI - Repair and paint (complete)	<b>481,50</b>
---	---------------
