**OPEL INSIGNIA: 1JVV587**

**Limited Technical Inspection**

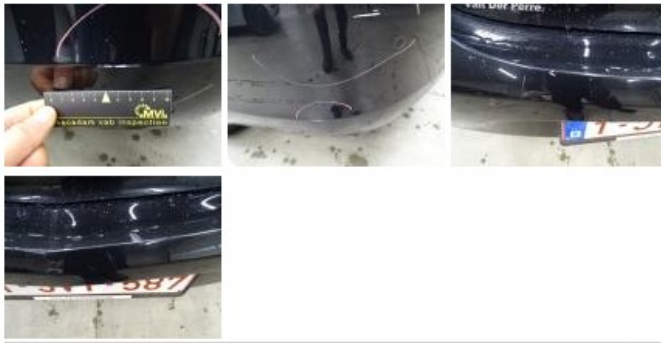
Bumper R, Scratch(es), LI - Repair and paint (complete)

211,80
