SKODA Superb: 1DKO672			
Vinnnumber:	<b>TMBJJ73T0C9070002</b>	Versionname:	<b>SUPERB COMBI GreenLin.Ambition DPF 105PK</b>
First Registrationdate:	<b>11/06/2012</b>	Fiscalpower:	<b>105PK</b>
Expertise Mileage:	<b>143149</b>	Power Kw:	<b>77</b>
Bodytype:	<b>Break</b>	Body color	<b>Black</b>
Gearbox:	<b>MAN 5 VIT</b>	Paint type	<b>Metalic</b>
Transmission:	<b>Front</b>	Rims summer	<b>Aluminium</b>
Fueltype:	<b>Diesel</b>	Oil level	<b>OK</b>
Battery functioning	<b>Yes</b>	Parking lot	<b>1733</b>
Number of doors	<b>5</b>		
Number of seats	<b>5</b>		
Number head rests	<b>5</b>		
Rims summer	<b>Aluminium</b>		
Category	<b>Passenger Car</b>		
Oil level	<b>OK</b>

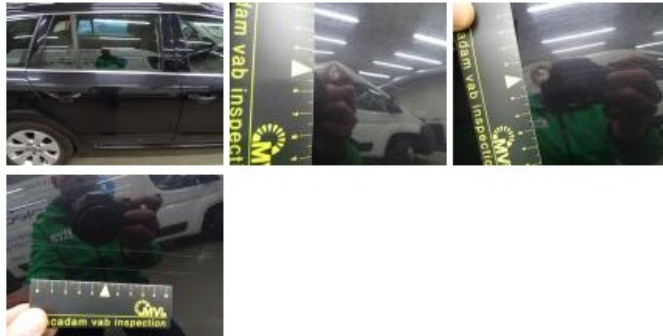
Door R R, Bump(s) and scratch(es), LI - Repair and paint (complete) 382,02

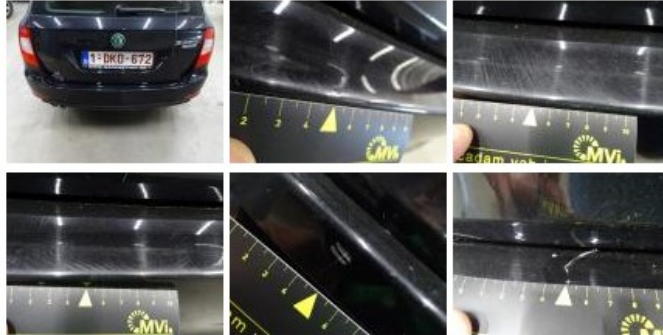
Bumper R, Scratch(es), LI - Repair and paint (complete) 254,16

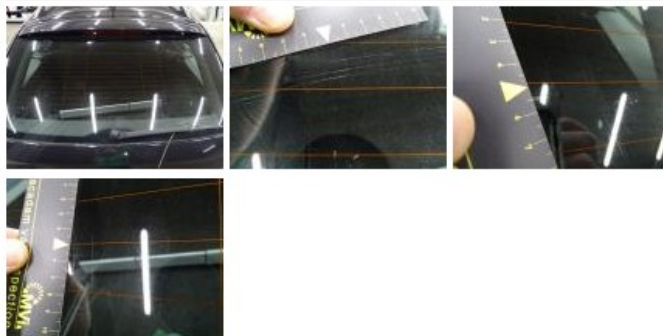
Rear window, Scratch(es), E - Replace 0,00
