HYUNDAI I40: 1ESH210

Limited Technical Inspection

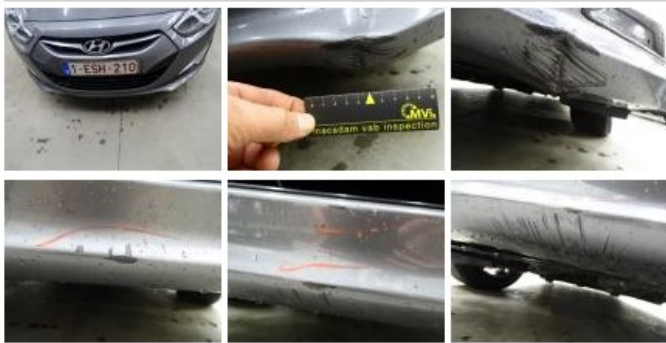
Front bumper, Bump(s) and scratch(es), LI - Repair and paint (complete)	211,80
---	---------------

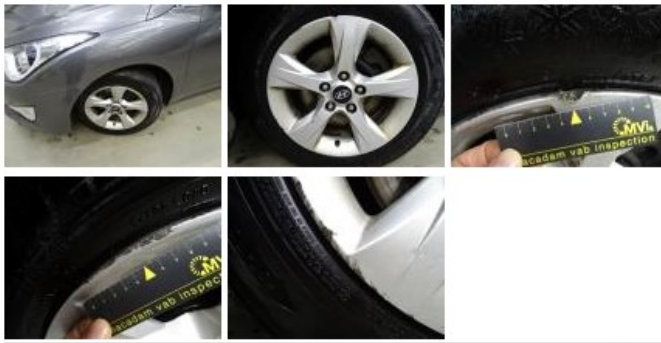
Alloy rim F L, Scratch(es), LI - Repair and paint (complete) 95,00
