MERCEDES A: 1EWC184

Limited Technical Inspection

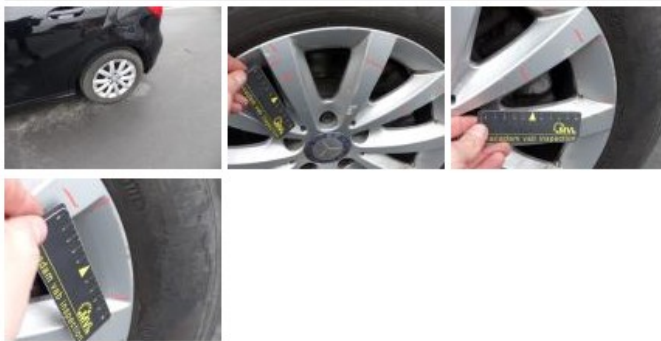
Alloy rim R L, Scratch(es), LI - Repair and paint (complete) 95,00

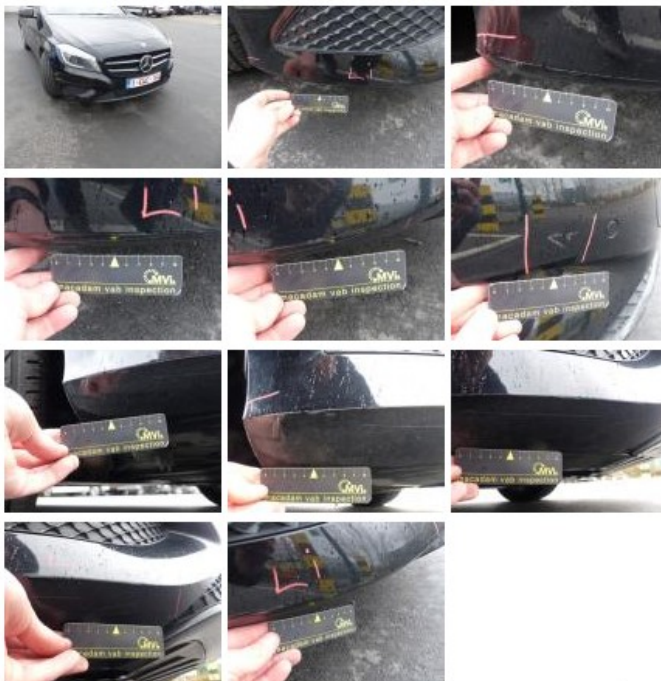
Front bumper, Scratch(es), LI - Repair and paint (complete) 259,80

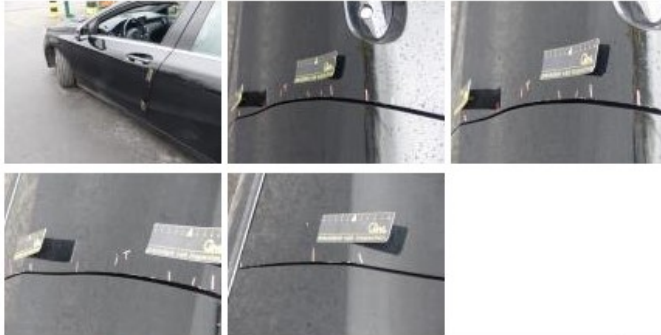
Door F L, Scratch(es), It - Spot repair 115,56

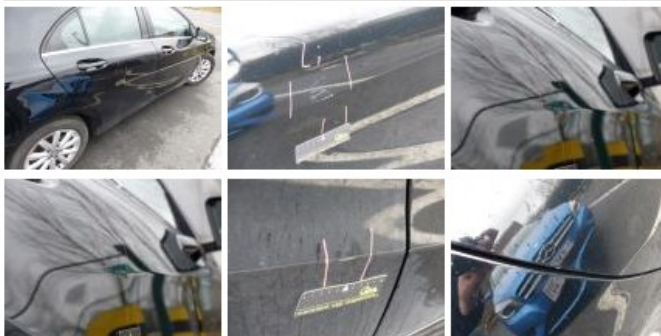
Door R R, Bump(s) and scratch(es), LI - Repair and paint (complete) 414,35
