**MERCEDES B: 1GCV621**

**Limited Technical Inspection**

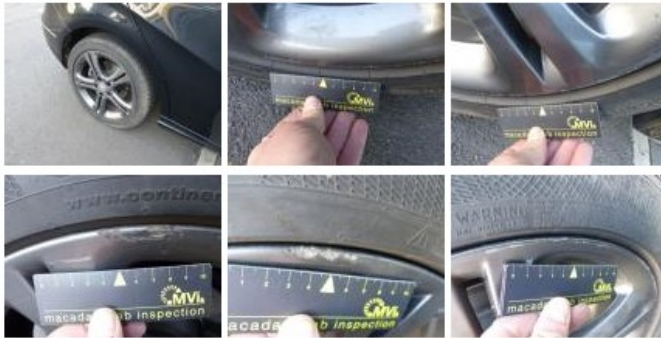
Alloy rim R R, Scratch(es), LI - Repair and paint (complete)

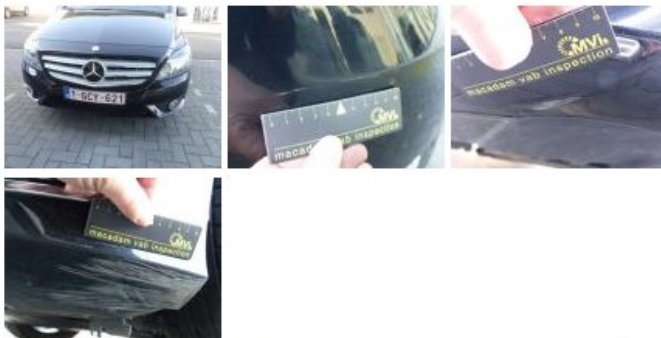
Front bumper, Scratch(es), LI - Repair and paint (complete)

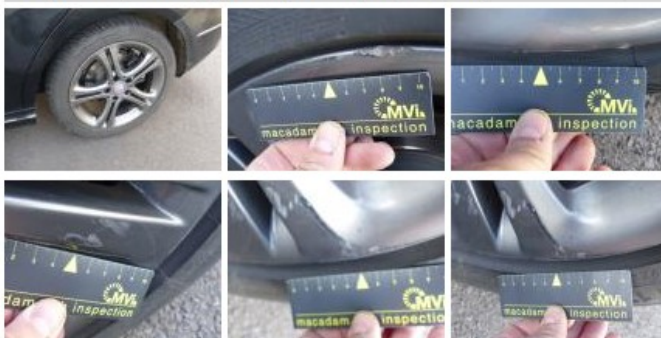
Alloy rim R L, Scratch(es), LI - Repair and paint (complete)

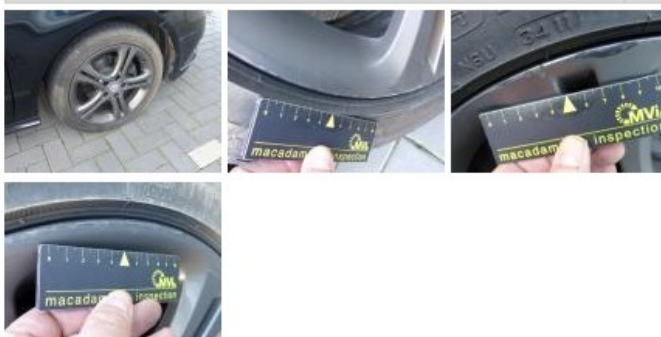
Alloy rim F R, Scratch(es), LI - Repair and paint (complete)

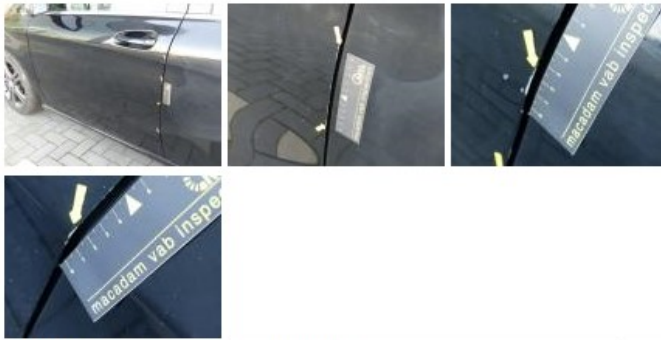
Door F L, Scratch(es), LI - Repair and paint (complete) 318,35

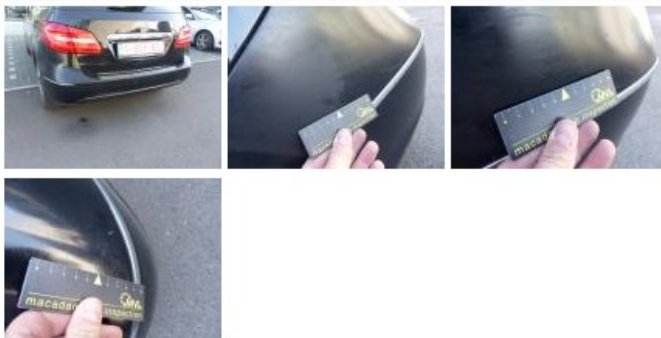
Bumper R, Bad repair, LI - Repair and paint (complete) 211,80
