**MERCEDES A: 1HJK341**

**Limited Technical Inspection**

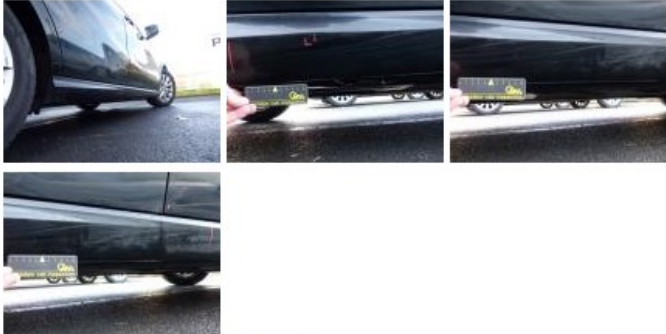
Sill outer R, Scratch(es), LI - Repair and paint (complete)		334,50
