MERCEDES A-CLASSE: 1GKZ779

Limited Technical Inspection

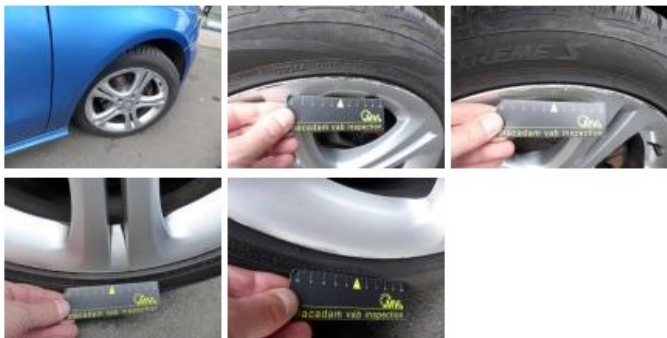
Alloy rim F R, Scratch(es), LI - Repair and paint (complete)	95,00
--	--------------

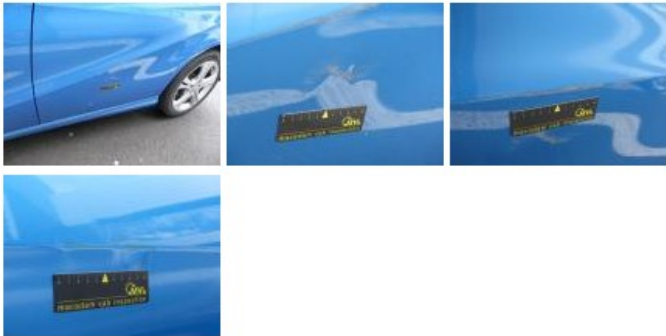
Bonnet, Bump(s), Acceptable	0,00
<i>No pictures to display</i>	
Roof pillar R, Bump(s), Acceptable	0,00
<i>No pictures to display</i>	
Door R L, Bump(s) and scratch(es), LI - Repair and paint (complete)	414,35

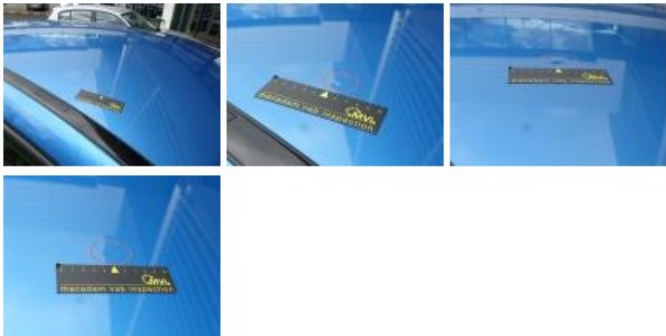
Roof, Bump(s), PDR - Knock out without painting	102,60

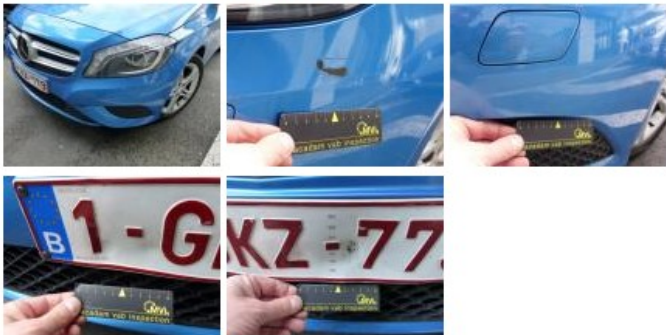
Front bumper, Bump(s) and scratch(es), LI - Repair and paint (complete)	259,80

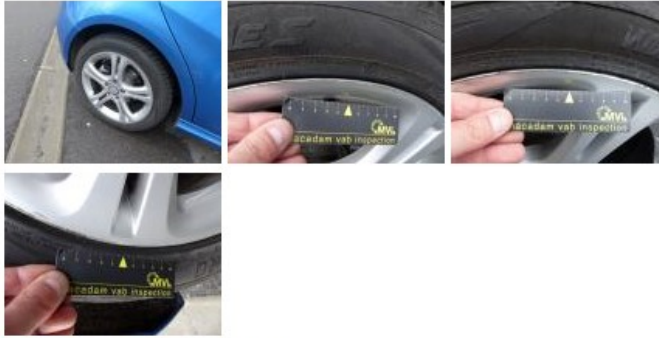
Alloy rim R R, Scratch(es), LI - Repair and paint (complete)
