MERCEDES CLA: 1FXT838

| Vinnnumber: | WDD1173011N059164 | Versionname: | CLA BER 200 CDI 136PK |

Limited Technical Inspection

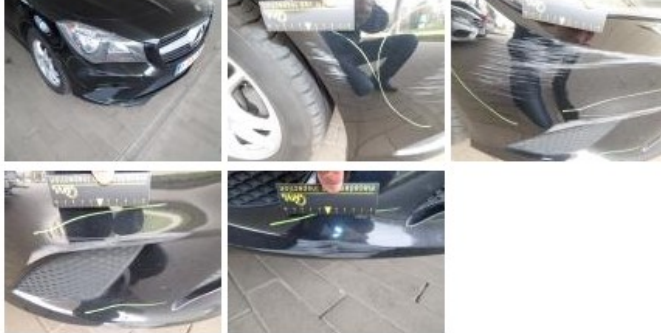
| Front bumper, Scratch(es), LI - Repair and paint (complete) | 211,80 |
