OPEL Astra: 1DST142

Limited Technical Inspection

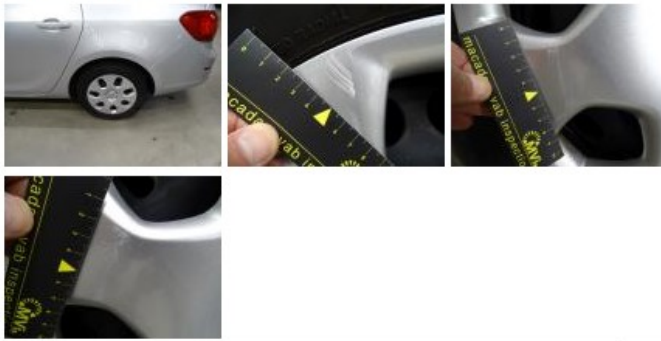
Wheel cover R L, Scratch(es), E - Replace 30,00

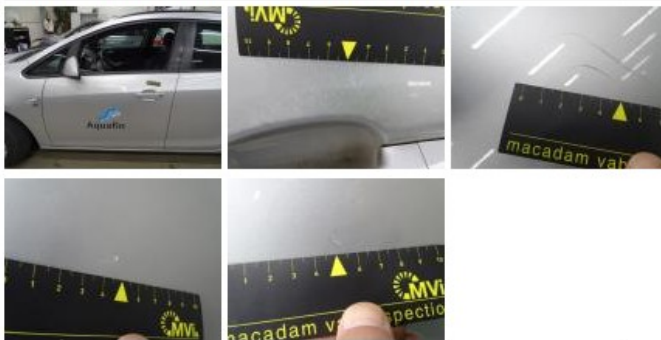
Door F L, Scratch(es), LI - Repair and paint (complete) 318,35
