PEUGEOT 2008: 1GFD765

Vinnumber:	VF3CU9HP0DY088267	Versionname:	2008 e-HDi Allure 92PK
First Registrationdate:	22/01/2014	Fiscalpower:	
Expertise Mileage:	74400	Power Kw:	68
Bodytype:	Break	Body color:	Dark Grey
Gearbox:	MAN 5 VIT	Paint type:	Metalic
Transmission:	Front	Rims summer:	Aluminium
Fueltype:	Diesel	Oil level:	OK
Maintenance:	OK	Parking lot:	2533
Battery functioning:	Yes		
Number of doors:	5		
Number of seats:	5		
Number head rests:	5		
Rims summer:	Aluminium		
Category:	Passenger Car		
Oil level:	OK		
Registration Certificate Car (BE):	Yes

Limited Technical Inspection

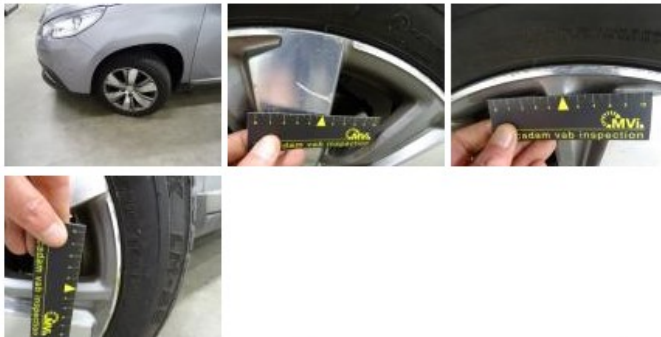
Bumper corner R L, Scratch(es), Acceptable	0,00
<i>No pictures to display</i>	
Alloy rim F L, Scratch(es), LI - Repair and paint (complete)	95,00
