**VOLVO V60: 1EMA928**

**Limited Technical Inspection**

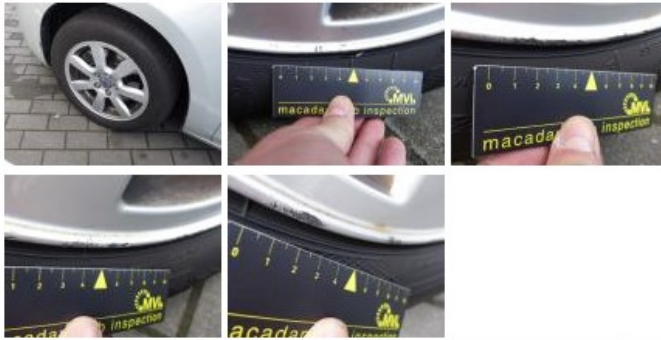
Alloy rim F L, Scratch(es), LI - Repair and paint (complete) 95,00

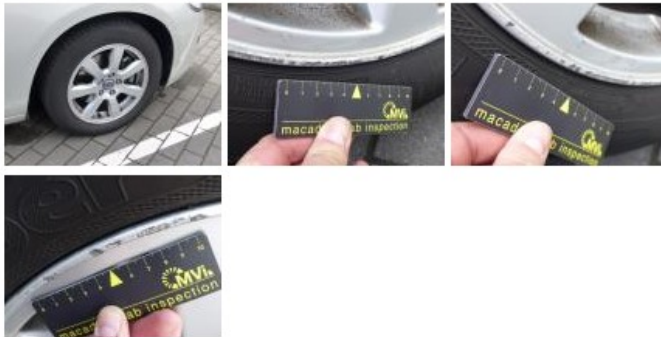
Alloy rim F R, Scratch(es), LI - Repair and paint (complete) 95,00
