AUDI A6: 1FEB438

Limited Technical Inspection

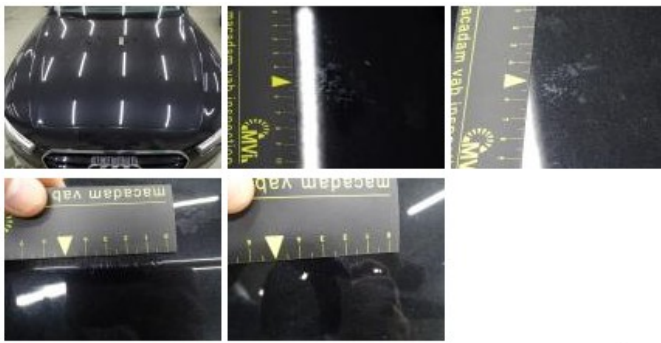
Roof, Chemical polution, LI - Repair and paint (complete) 577,80

Bonnet, Chemical polution, LI - Repair and paint (complete) 348,09

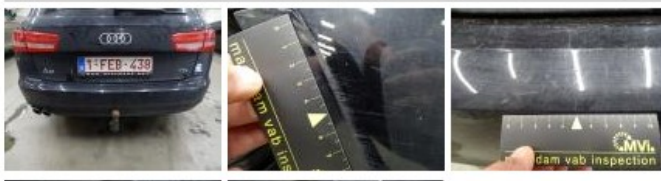
Wing R L, Scratch(es), LI - Repair and paint (complete) 369,84

Bumper R, Scratch(es), LI - Repair and paint (complete) 254,16

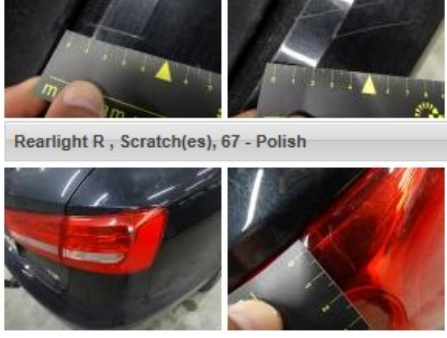
Rearlight R, Scratch(es), 67 - Polish 55,19
