VOLKSWAGEN Golf: DA0376

Limited Technical Inspection

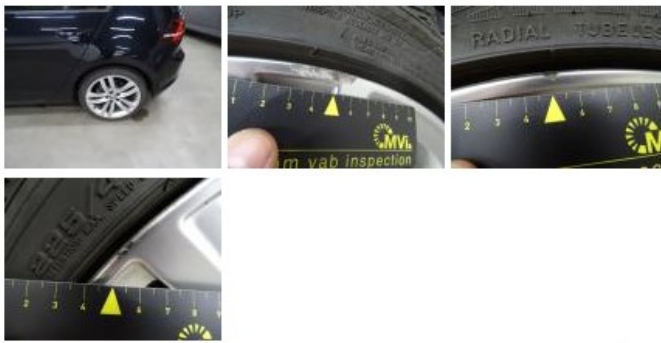
Alloy rim R L, Scratch(es), LI - Repair and paint (complete)	95,00
--	-------

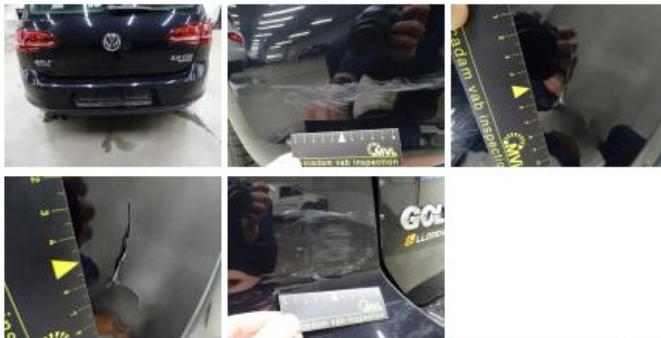
Bumper R, Damaged, E - Replace 415,20

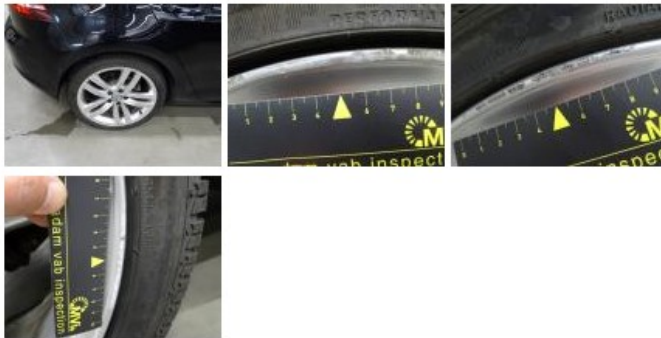
Alloy rim R R, Scratch(es), LI - Repair and paint (complete) 95,00
