**BMW 3: 1GGL339**

**Limited Technical Inspection**

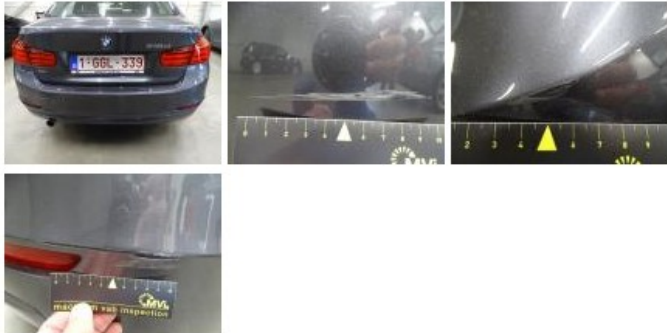
Bumper R, Scratch(es), LI - Repair and paint (complete)	211,80

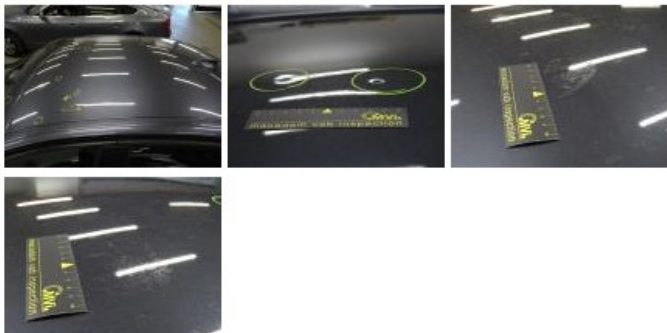
Roof, Hail damage, PDR - Hail	300,00

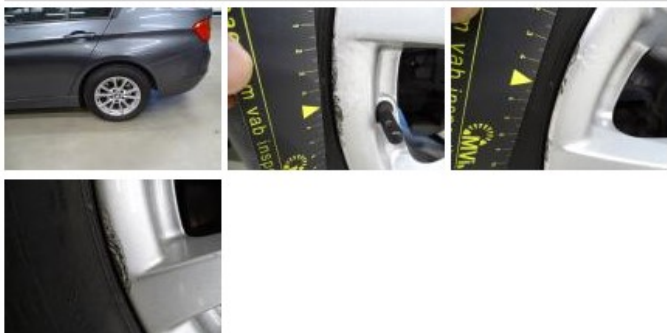
Alloy rim R L, Scratch(es), LI - Repair and paint (complete)	95,00
