**VOLKSWAGEN GOLF VARIANT: 1PDN909**

**Limited Technical Inspection**

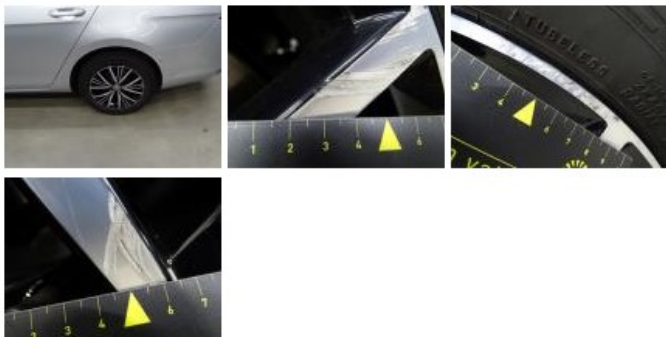
Alloy rim R R polished, Damaged, E - Replace 235,20

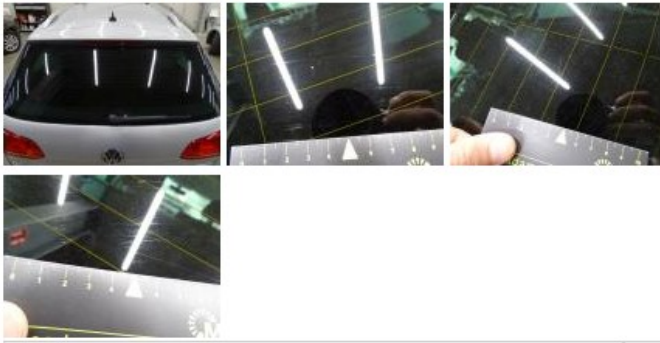
Rear window, Scratch(es), E - Replace 0,00

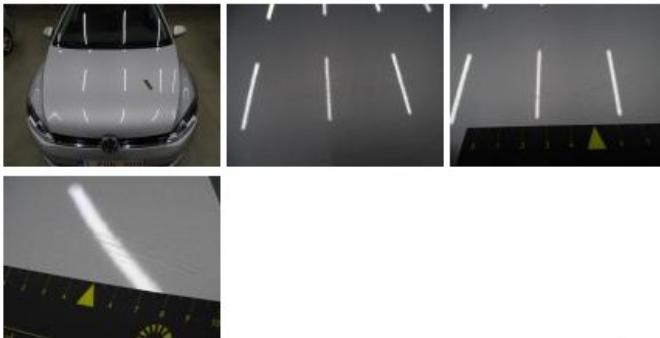
Bonnet, Scratch(es), LI - Repair and paint (complete) 290,08

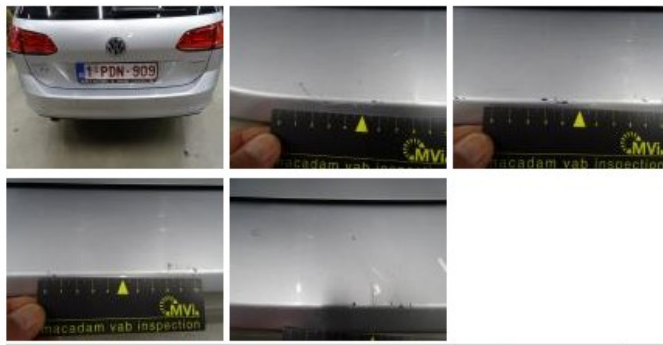
Bumper R, Scratch(es), LI - Repair and paint (complete) 211,80
