VOLKSWAGEN Golf: 1HJS010

Limited Technical Inspection

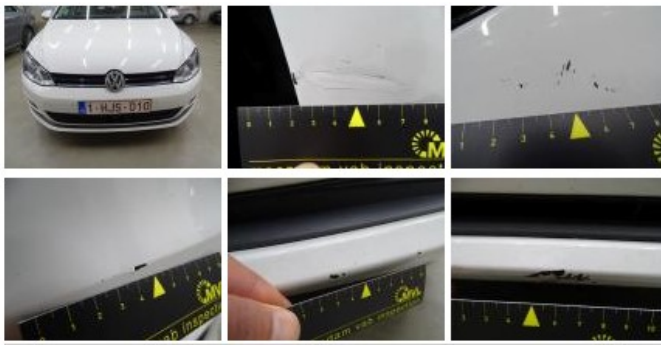
Front bumper, Scratch(es), LI - Repair and paint (complete)	211,80
---	---------------
