**LU Skoda Octavia: ME9491**

**Limited Technical Inspection**

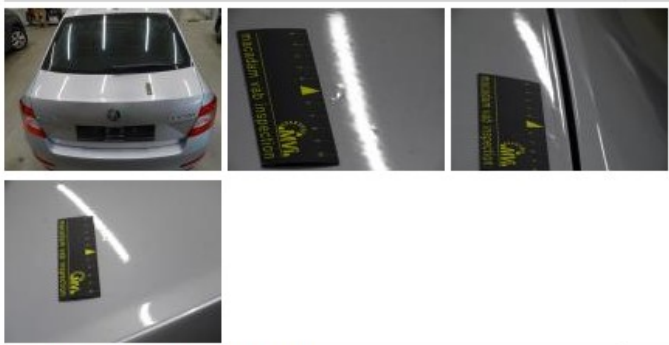
Tailgate, Bad repair, Paint	0,00
-----------------------------	------
