BMW 5: 1GKJ723

| Vinnnumber: | WBA5J31060D710660 | Versionname: | 5 TOURING 520dA 163PK Aut. |

Limited Technical Inspection

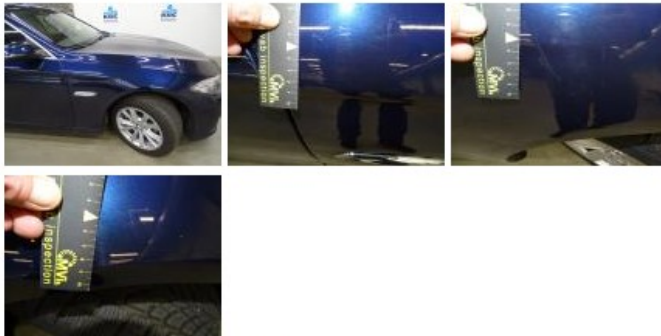
Wing F R, Scratch(es), LI - Repair and paint (complete) 264,21
