**BMW 5: 1GQH330**

**Limited Technical Inspection**

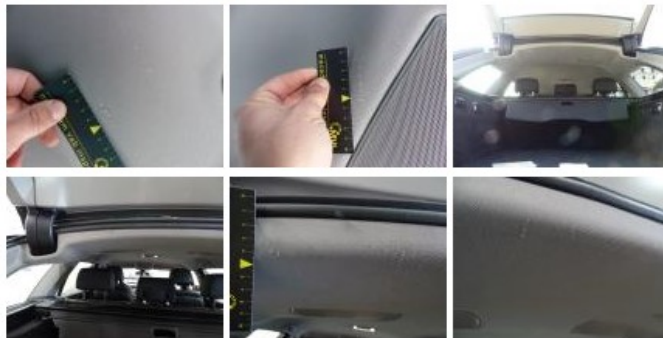
Ceiling, Scratch(es), Smart repair 64,32
