OPEL Astra: 1FBP136

Limited Technical Inspection

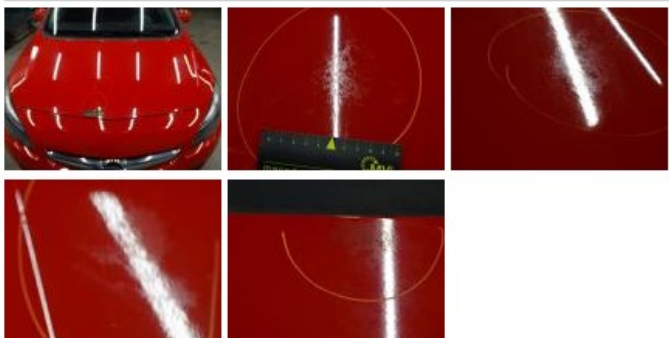
Bonnet, Chemical polution, LI - Repair and paint (complete)	290,08
---	---------------

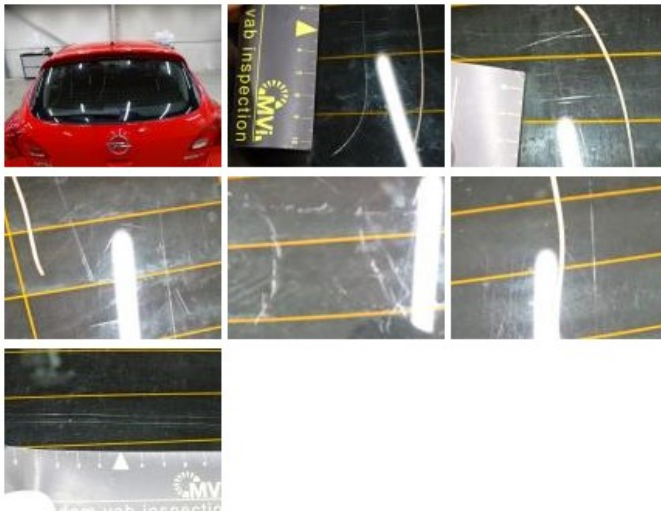
Rear window, Scratch(es), E - Replace 0,00

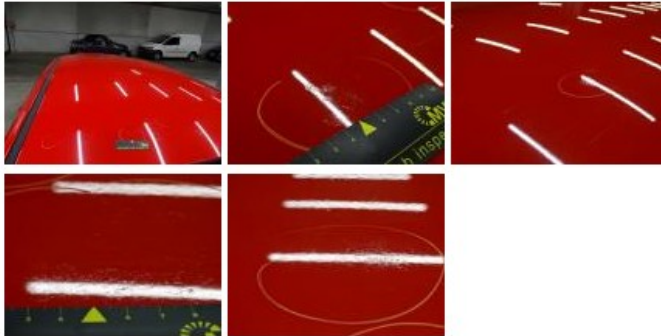
Roof, Chemical polution, LI - Repair and paint (complete) 481,50

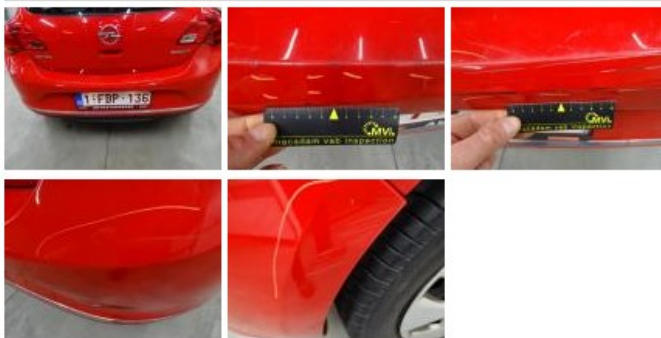
Bumper R, Scratch(es), LI - Repair and paint (complete) 211,80

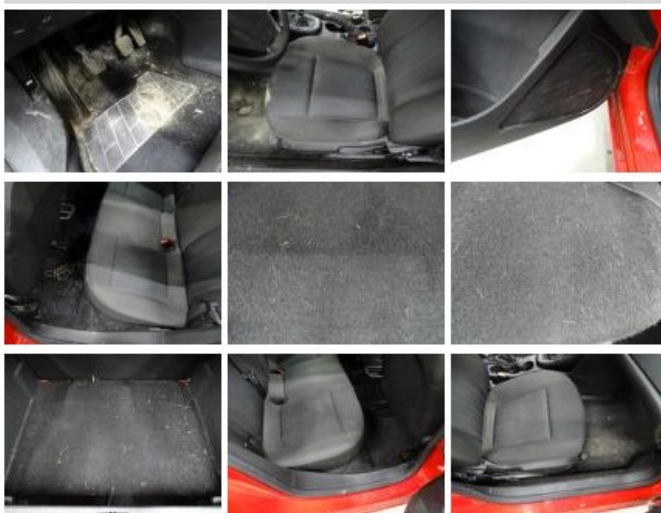
Interior, Dirty, Cleaning 100,00

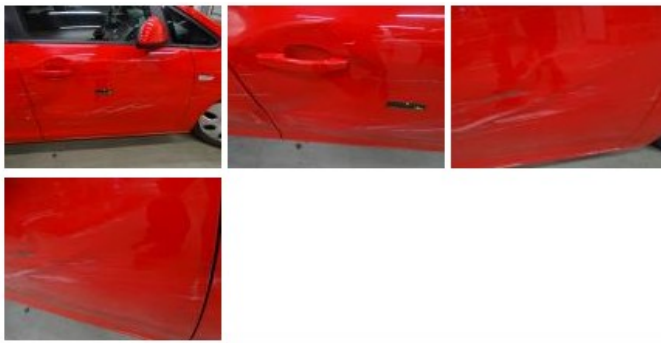
Door F R, Bump(s) and scratch(es), Le - Replace and paint 0,00

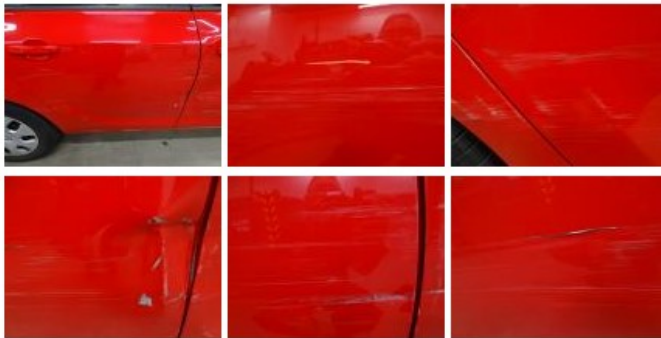
Door R R, Bump(s) and scratch(es), Le - Replace and paint 0,00

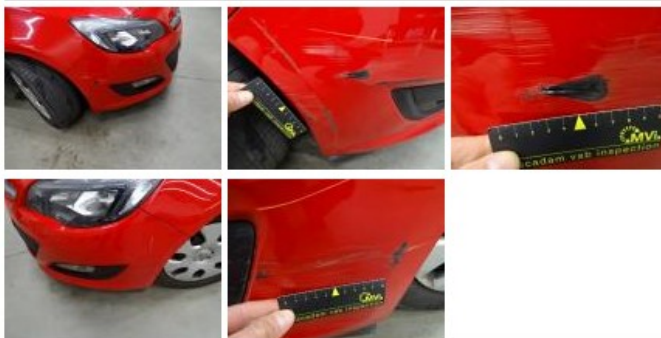
Front bumper, Bump(s) and scratch(es), LI - Repair and paint (complete) 0,00

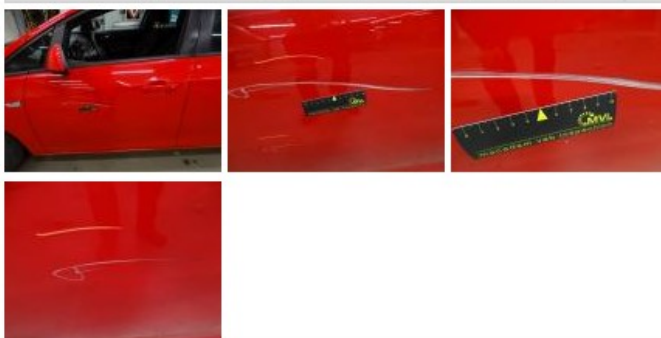
Door F L, Bump(s) and scratch(es), LI - Repair and paint (complete) 318,35
