IVECO Daily 40C15: 1CFT107

Limited Technical Inspection

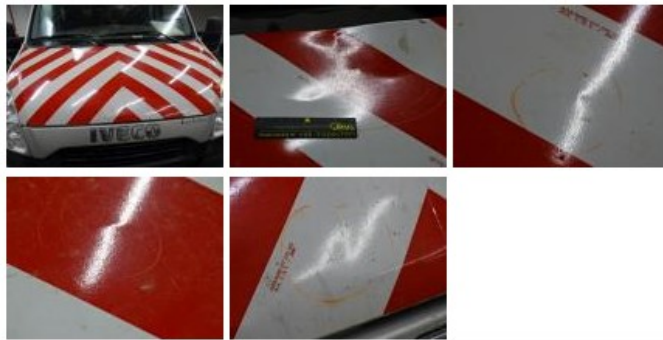
Bonnet, Bump(s), LI - Repair and paint (complete) 217,56

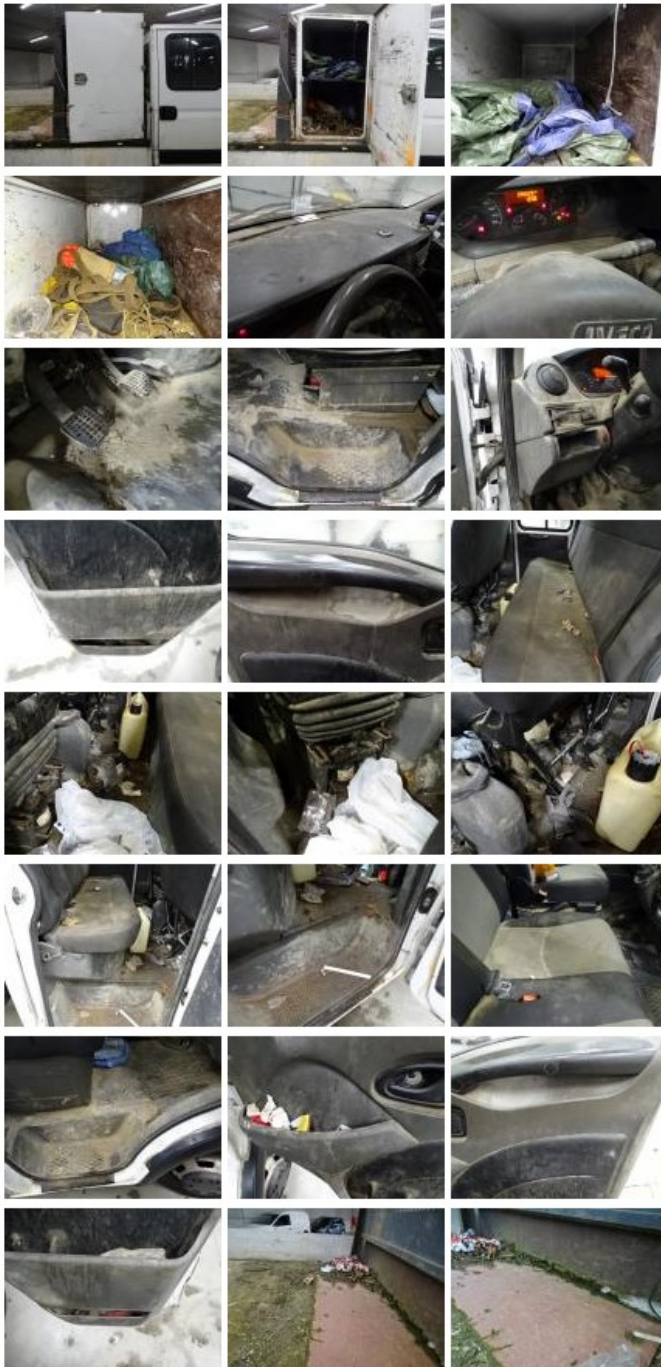
Interior, Dirty, Cleaning 150,00

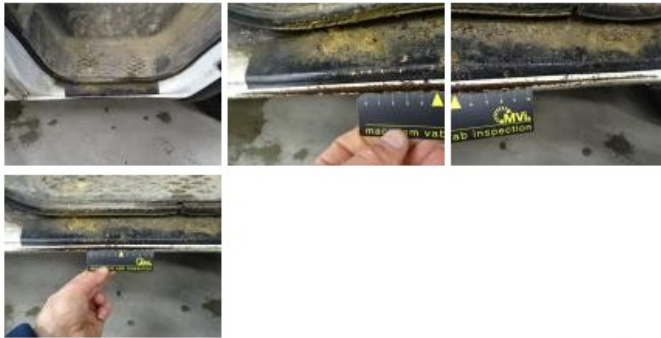
Sill outer R, Rust, LI - Repair and paint (complete)

232,88
