**SKODA OCTAVIA: 1JNG656**

**Limited Technical Inspection**

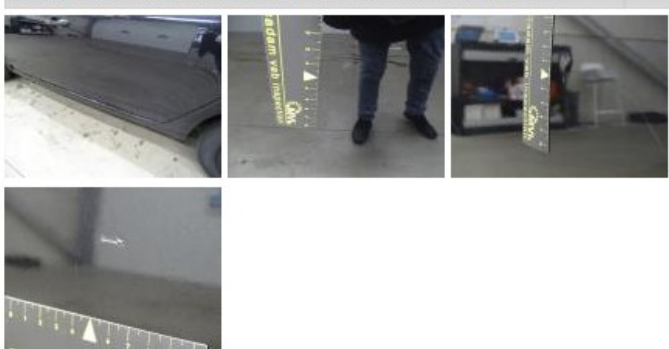
Door R L, Bump(s) and scratch(es), LI - Repair and paint (complete)	318,35
---------------------------------------------------------------------	--------
