**PEUGEOT 3008: 1DGO171**

**Limited Technical Inspection**

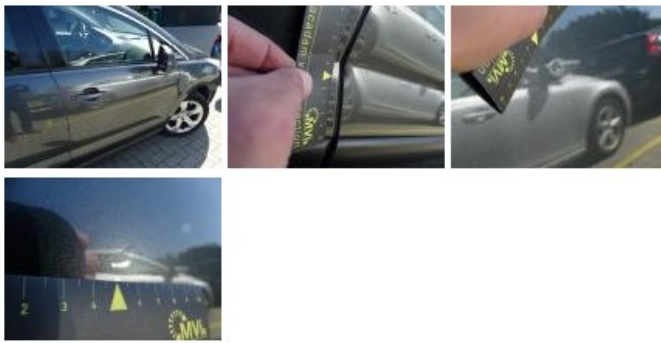
Door F R, Bump(s) and scratch(es), LI - Repair and paint (complete)	<b>318,35</b>
---------------------------------------------------------------------	---------------
