SKODA Octavia: 1GIQ642

Limited Technical Inspection

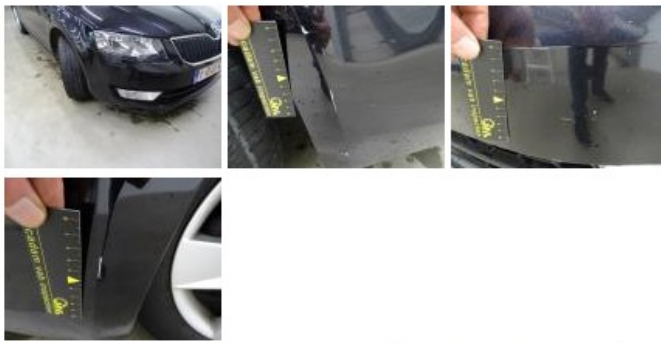
Front bumper, Scratch(es), LI - Repair and paint (complete)	211,80
---	--------
