## VOLVO V40: 1GQV638

## Limited Technical Inspection

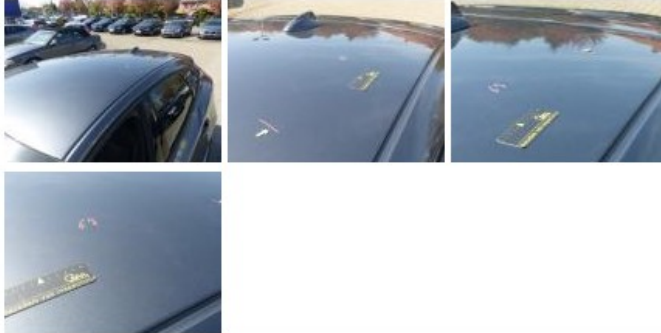
Roof, Scratch(es), 67 - Polish

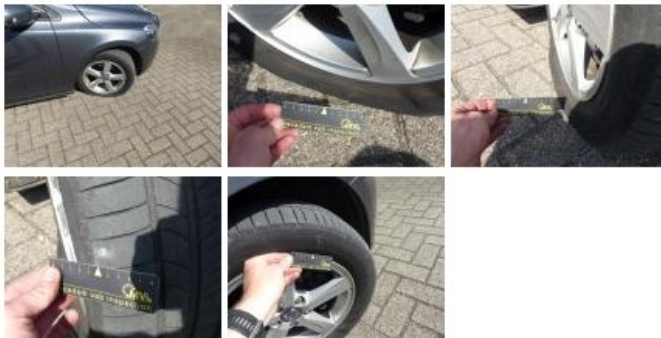
Tyre F R, Flat, E - Replace

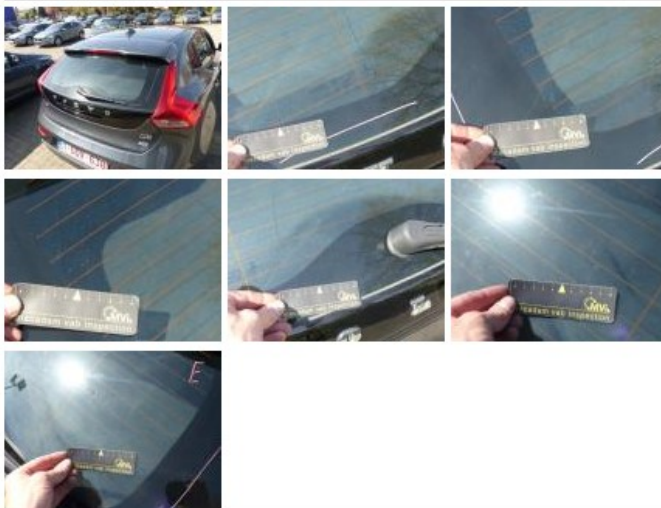
Rear window, Scratch(es), E - Replace
