TOYOTA AVENSIS TOURING SPORTS: 1NKT746

Limited Technical Inspection

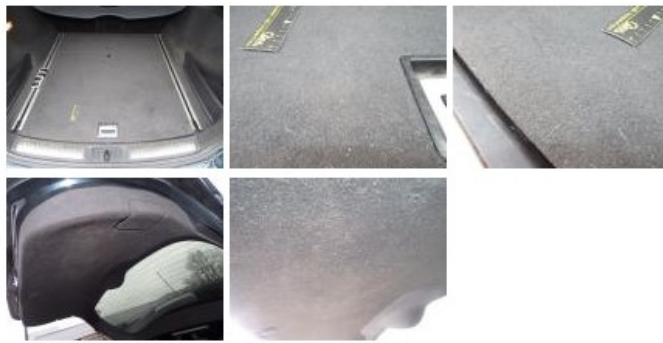
Boot carpet, Dirty, Chemical cleaning	50,00
---------------------------------------	-------

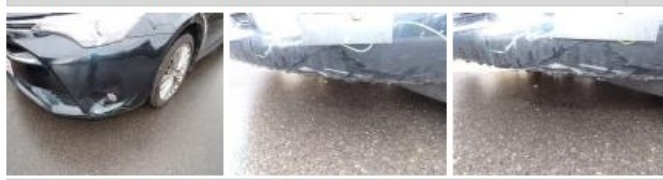
Front bumper, Scratch(es), LI - Repair and paint (complete) 211,80

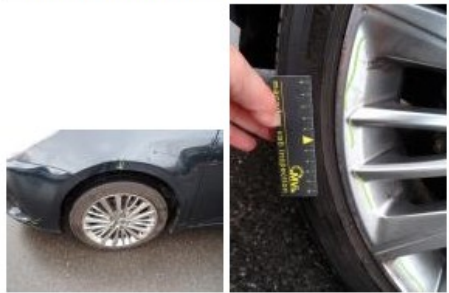
Alloy rim F L polished, Scratch(es), LI - Repair and paint (complete) 95,00
