**SKODA Superb: 1GHH147**

**Limited Technical Inspection**

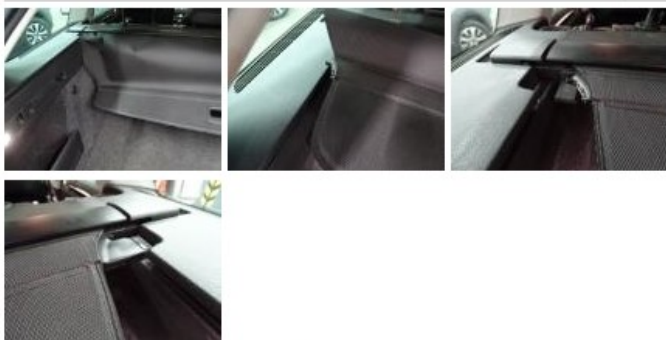
Total cost ex VAT	1604,96
Luggage space cover, Damaged, E - Replace	288,00

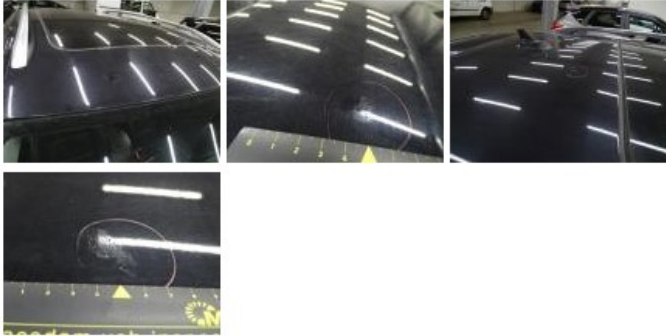
Roof, Chemical pollution, LI - Repair and paint (complete)	577,80

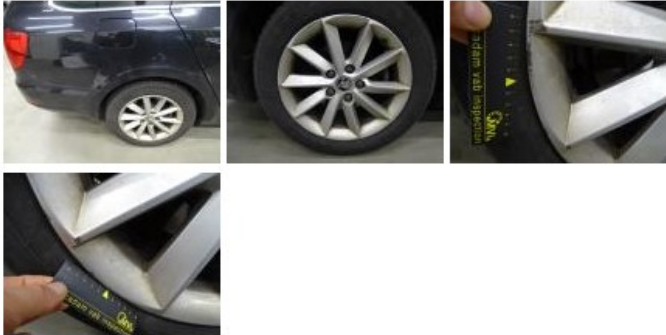
Alloy rim R R, Scratch(es), LI - Repair and paint (complete)	95,00
