**FORD Mondeo: 1EZL410**

**Limited Technical Inspection**

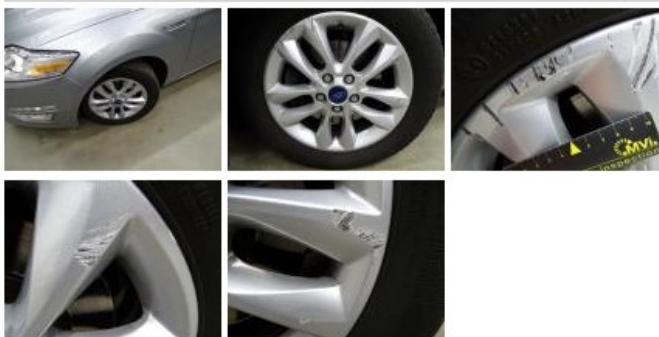
Alloy rim F L, Scratch(es), LI - Repair and paint (complete) **95,00**
