HYUNDAI i20: 1EUG830

Limited Technical Inspection

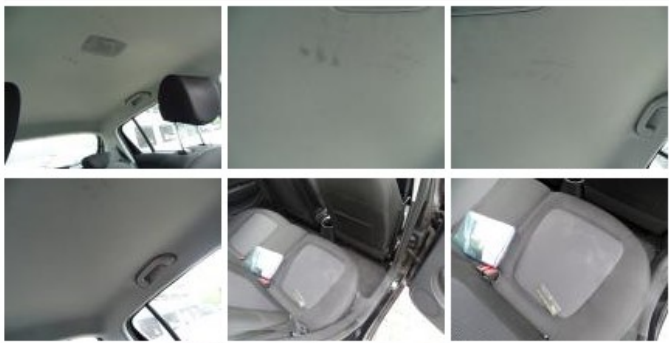
Total cost ex VAT	2412,18
Interior, Stain, Cleaning	100,00

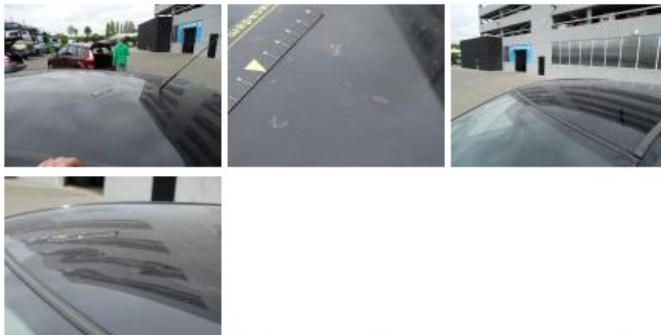
Roof, Rust, LI - Repair and paint (complete) 481,20
