AUDI A1: 1FJC030

Limited Technical Inspection

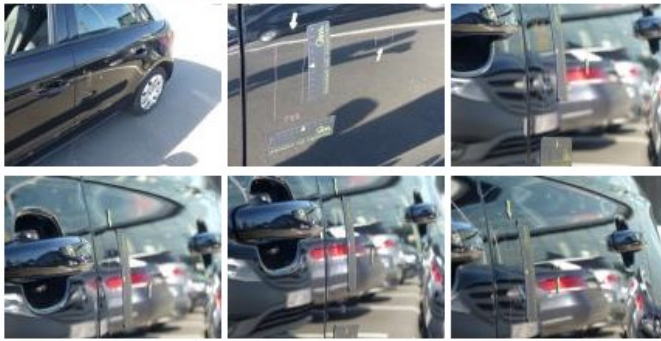
Door R L, Bump(s), PDR - Knock out without painting 63,00

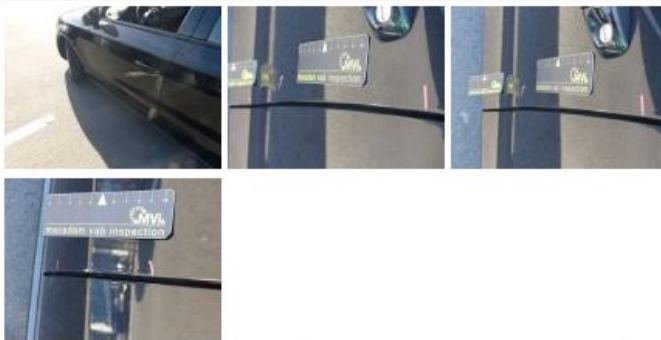
Door F L, Scratch(es), It - Spot repair 115,56

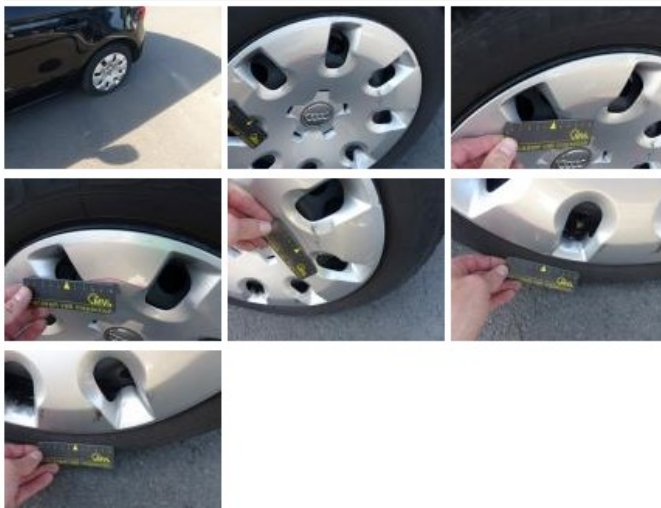
Wheel cover R L, Scratch(es), E - Replace 24,00

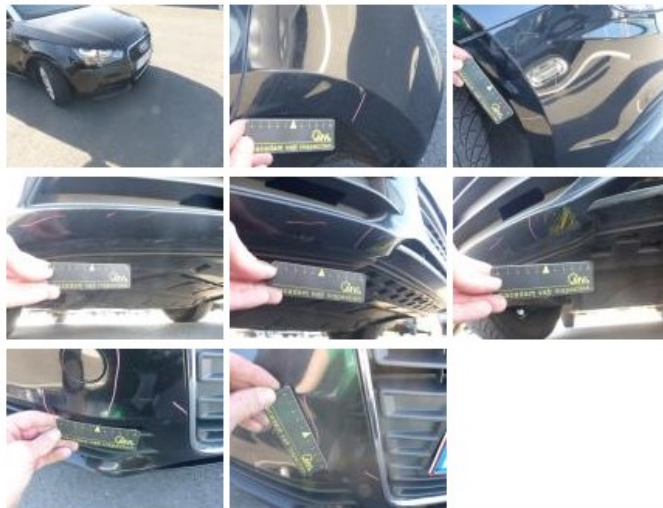
Front bumper, Scratch(es), LI - Repair and paint (complete) 217,44

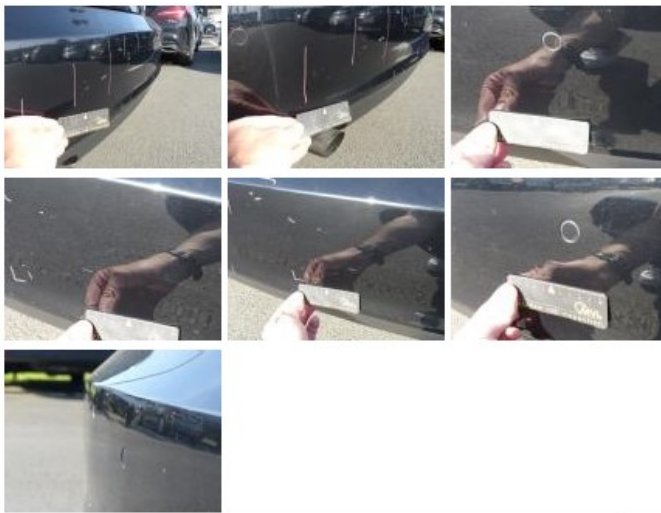
Bumper R, Damaged, LI - Repair and paint (complete) 217,44
