**BMW 3: 1FDU729**

**Limited Technical Inspection**

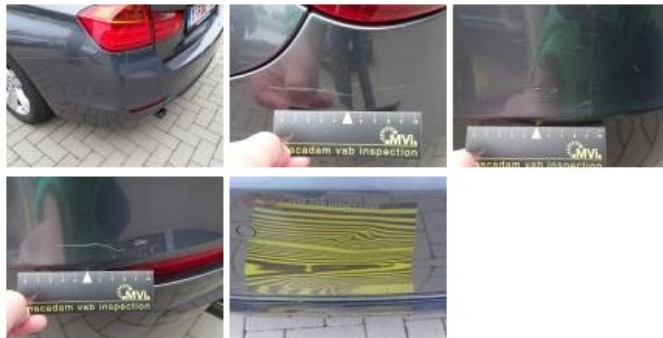
Bumper R, Bump(s) and scratch(es), LI - Repair and paint (complete) 259,80
