**AUDI Q5: 1GMK559**

**Limited Technical Inspection**

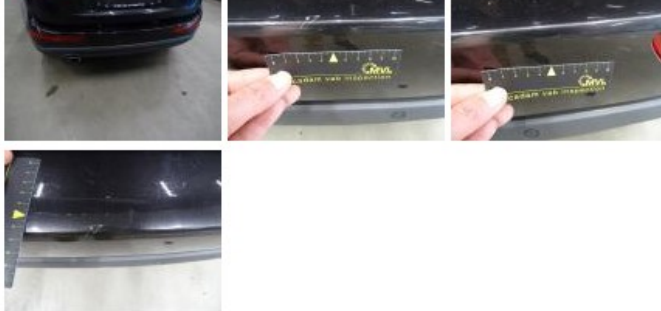
Bumper R, Scratch(es), LI - Repair and paint (complete) 254,16
