BMW 1: 1FXC153

Limited Technical Inspection

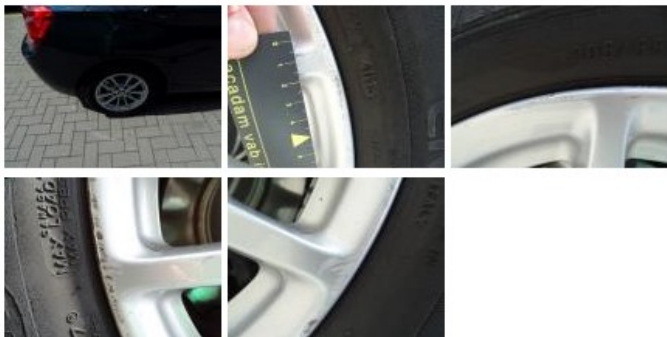
Total cost ex VAT	970,92
Alloy rim R R, Scratch(es), LI - Repair and paint (complete)	95,00

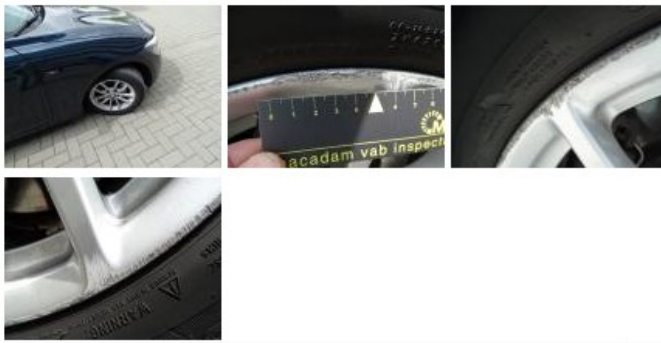
Alloy rim F R, Scratch(es), E - Replace 235,20

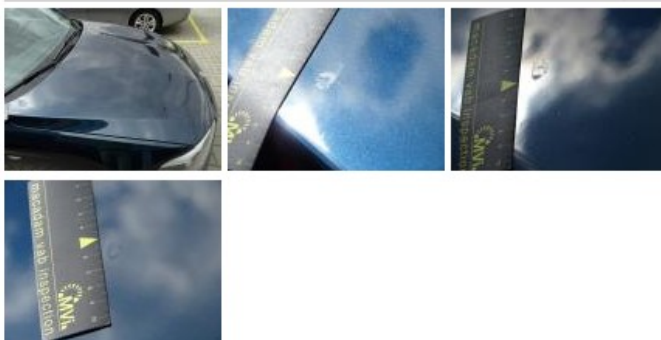
Bonnet, Chemical pollution, LI - Repair and paint (complete) 290,08

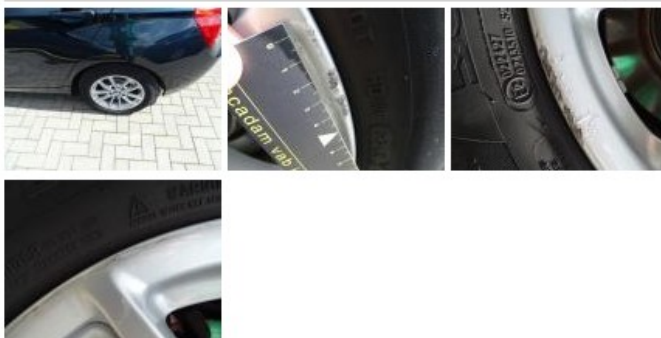
Alloy rim R R, Scratch(es), LI - Repair and paint (complete) 95,00
