**SKODA Superb: 1EWX042**

**Limited Technical Inspection**

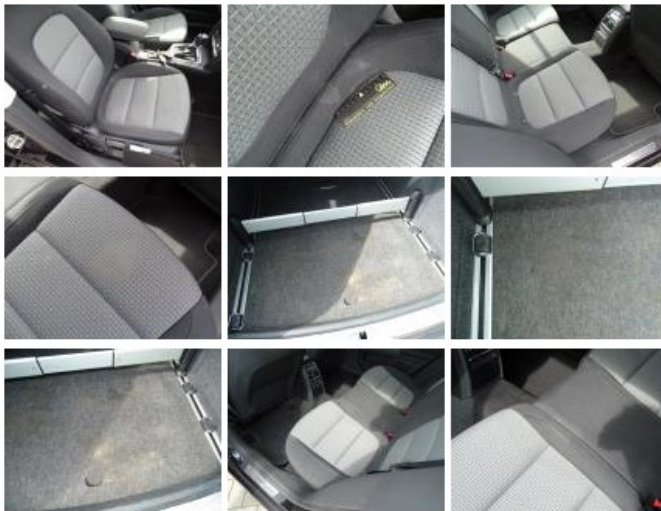
Interior, Stain, Cleaning 100,00

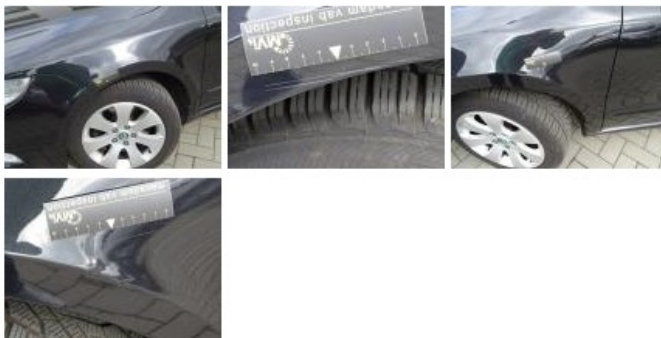
Wing F L, Scratch(es), LI - Repair and paint (complete) 264,21

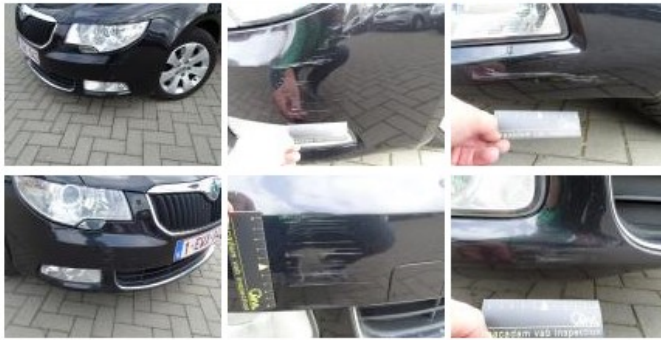
Front bumper, Scratch(es), LI - Repair and paint (complete) 254,16

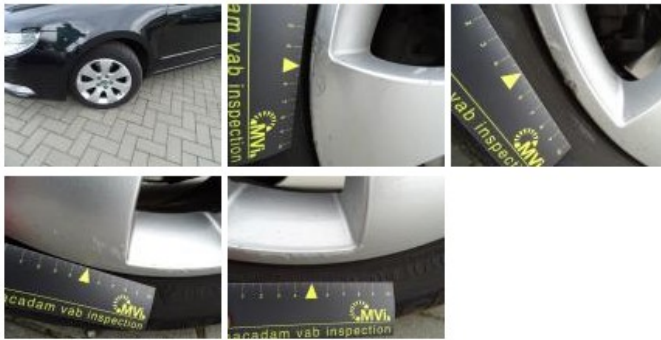
Alloy rim F L, Scratch(es), LI - Repair and paint (complete) 95,00

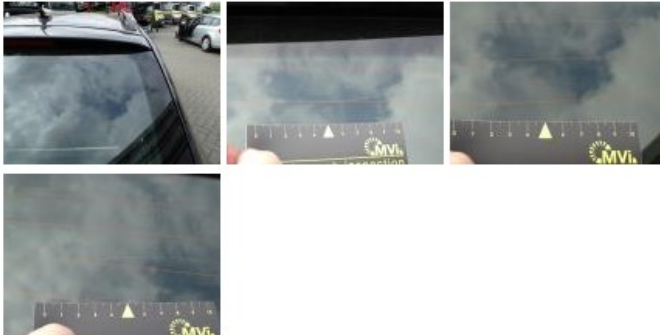
Rear window, Scratch(es), E - Replace 0,00

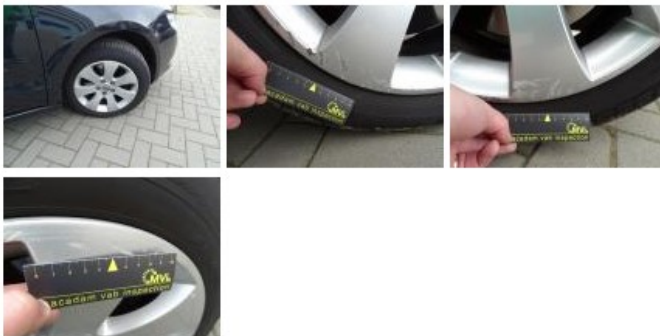
Alloy rim F R, Scratch(es), LI - Repair and paint (complete) 95,00
