VOLVO V70: 1EQ177

Limited Technical Inspection

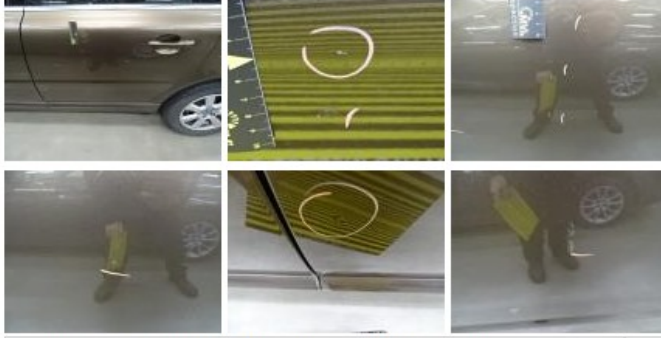
Door R L, Bump(s) and scratch(es), LI - Repair and paint (complete) 382,02

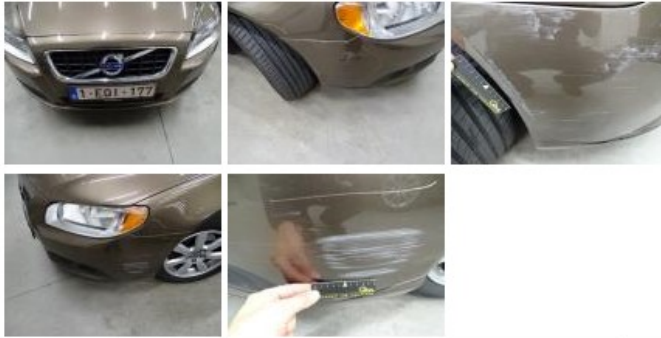
Front bumper, Scratch(es), LI - Repair and paint (complete) 0,00
