VOLVO V40: 1EQD372			
Vinnnumber:	YV1MV8481D2041792	Versionname:	V40 D2 Base 115PK
First Registrationdate:	20/02/2013	Fiscalpower:	
Expertise Mileage:	163913	Power Kw:	84
Bodytype:	Hatchback	Body color:	Grey
Gearbox:	MAN 6 VIT	Paint type:	Metalic
Transmission:	Front	Rims summer:	Steel
Fueltype:	Diesel	Oil level:	OK
Battery functioning:	Yes	Parking lot:	2620
Number of doors:	5		
Number of seats:	5		
Number head rests:	5		
Rims summer:	Steel		
Category:	Passenger Car		
Oil level:	OK		
Registration Certificate Car (BE):	No

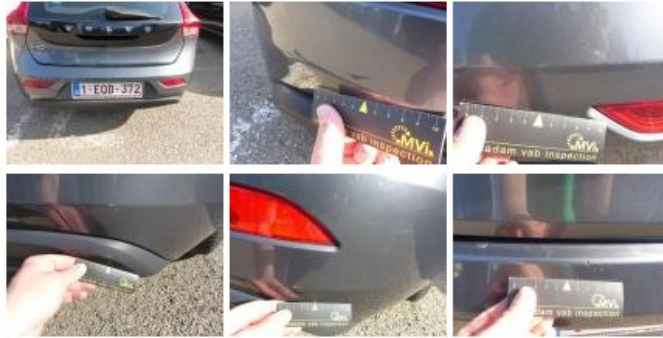
Wing R L, Scratch(es), Acceptable	0,00
<i>No pictures to display</i>	
Door F R, Scratch(es), Acceptable	0,00
<i>No pictures to display</i>	
Wheel cover F R, Scratch(es), Acceptable	0,00
<i>No pictures to display</i>	
Wing R R, Scratch(es), Acceptable	0,00
<i>No pictures to display</i>	
Bonnet, Scratch(es), Acceptable	0,00
<i>No pictures to display</i>	
Trunk lid covering R, Scratch(es), Acceptable	0,00
<i>No pictures to display</i>	
Front bumper, Scratch(es), Acceptable	0,00
<i>No pictures to display</i>	
Door R R, Scratch(es), Acceptable	0,00
<i>No pictures to display</i>	
Bumper R, Scratch(es), LI - Repair and paint (complete)	211,80
