VOLVO V40: 1FAN373			
Vinnnumber:	YV1MV8481D2054396	Versionname:	V40 D2 Base 115PK
First Registrationdate:	7/05/2013	Fiscalpower:	
Expertise Mileage:	128428	Power Kw:	84
Bodytype:		Body color:	Dark Blue
Gearbox:	MAN 6 VIT	Paint type:	Metalic
Transmission:	Front	Rims summer:	Aluminium
Fueltype:	Diesel	Oil level:	OK
Battery functioning:	Yes	Parking lot:	2333
Number of doors:	5		
Number of seats:	5		
Number head rests:	5		
Rims summer:	Aluminium		
Category:	Passenger Car		
Oil level:	OK

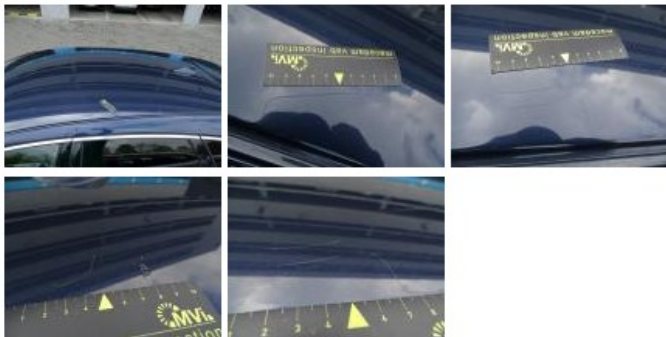
Total cost ex VAT	1241,90
Roof, Scratch(es), LI - Repair and paint (complete)	481,50
