**FORD Kuga: 1GJU104**

**Limited Technical Inspection**

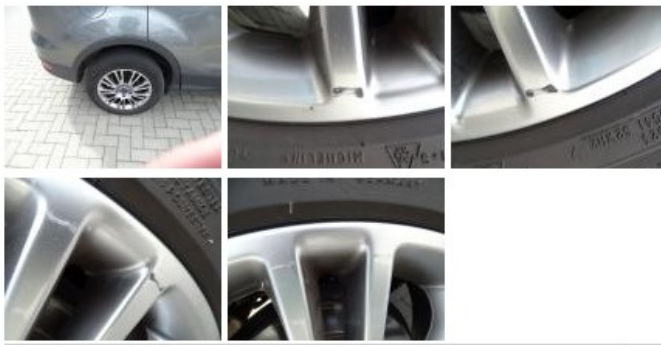
Alloy rim R R, Scratch(es), LI - Repair and paint (complete)	95,00
--	-------
