**BMW 5: 1GAE637**

| Vinnumber: | <b>WBA5J11090D065331</b> | Versionname: | <b>5 TOURING 518dA 136PK Aut.</b> |

**Limited Technical Inspection**

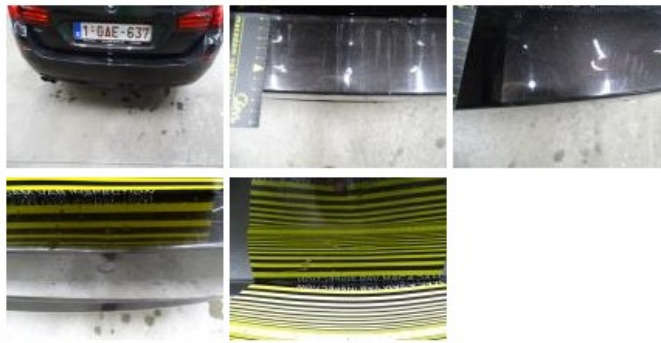
Bumper R, Bump(s) and scratch(es), LI - Repair and paint (complete) 254,16

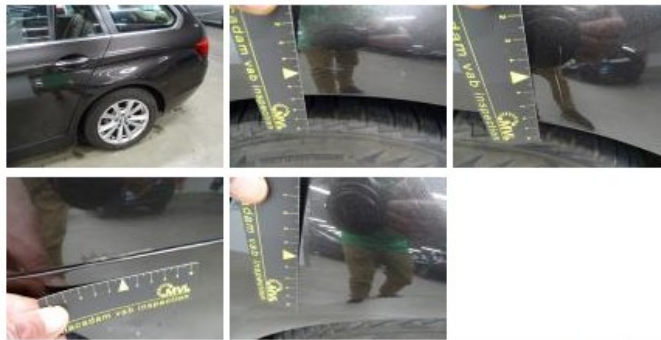
Wing R L, Bump(s) and scratch(es), LI - Repair and paint (complete) 0,00

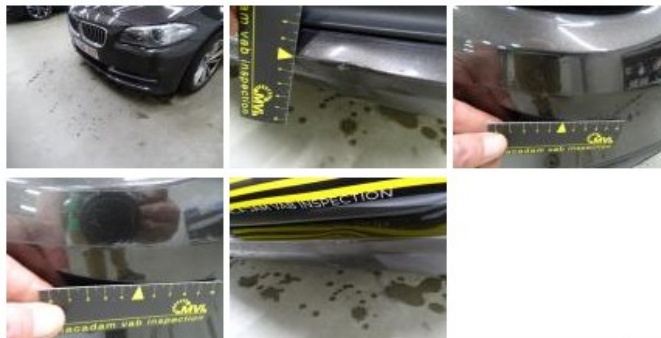
Front bumper, Bump(s) and scratch(es), LI - Repair and paint (complete) 254,16
