**BMW 5: 1GQF117**

**Limited Technical Inspection**

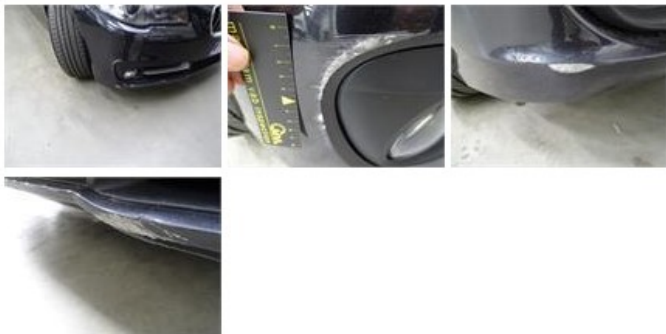
<b>Front bumper, Scratch(es), LI - Repair and paint (complete)</b>	<b>254,16</b>
--	---------------
